Village of New Denver Bosun Hall Building Assessment

9dot Engineering Inc.

Project Number: 16-013

Prepared for: Village of New Denver

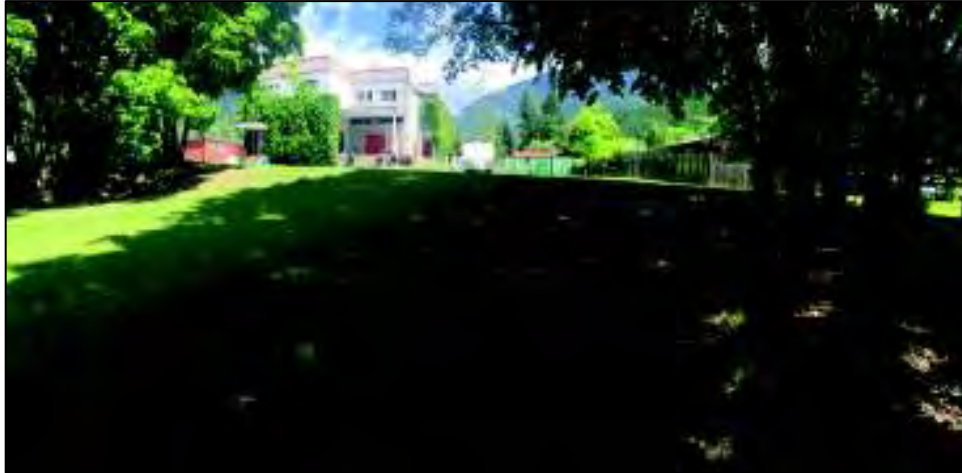
Overall, Bosun Hall is built on a low slope property with drainage issues that are impacting the building foundation. Drainage of water towards the building on the South and North sides of the building can result in moisture damage and accelerated deterioration of the structure. A swale and collection system should be constructed to correct these drainage issues and move moisture away from foundation walls. In addition drainage/grade improvement on the East side of the building is advised to prevent drainage issues from worsening (Figure 2). It is recommended that perimeter footing drainage be installed when re-grading and foundation replacement are done.

Figure 2 - Site Grading East of Building

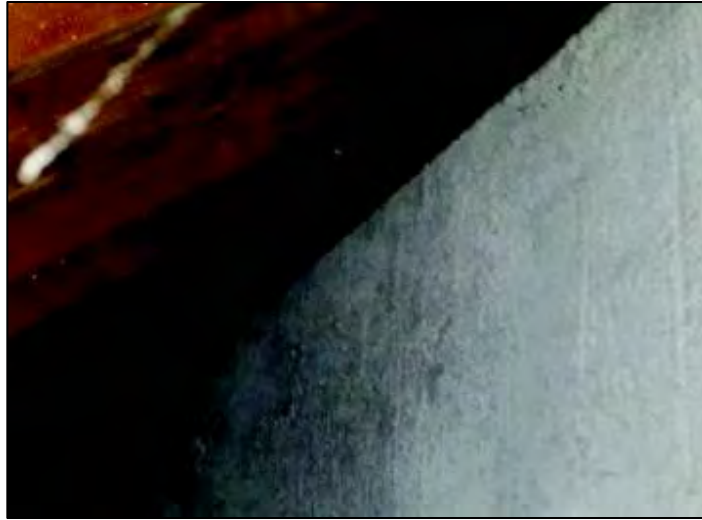
Some of the deteriorating attic members were sistered to increase their strength; however, the sistered members were not sized to provide adequate support. Rafters in the Hall, Kitchen, and Stage, are 2"x 8" 18"OC, 2"x 6" 16" OC and 2"x 6" 24"OC respectively. Two of the stage rafters appear to have been reinforced with sistered members. The Kitchen rafters appear to have been toe nailed onto the north wall without a ledger board (Figure 3). These connections should be reinforced to properly secure the rafters to the main building structure.

Figure 3 - No Ledger Board @ Kitchen Rafters

The existing roof and rafters are sagging. It is recommended that a new truss system be installed when the roof is replaced, as attempting to improve the existing structural system would be difficult and costly to modify.

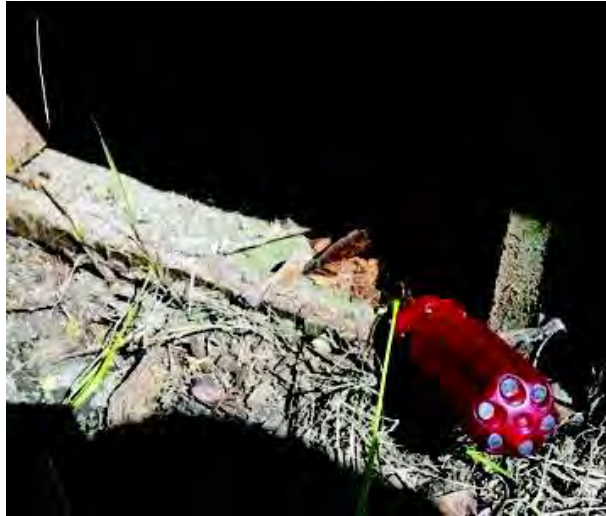
Much of the foundation appears to be pressure treated wood foundation (PTW), which may require significant replacement. PTW must be kept dry to prevent rot and mildew issues; however, Bosun Hall's foundation is not properly protected from surface water and groundwater drainage and seepage, leaving the foundation structure vulnerable to deterioration (Figure 4). During the inspection, the foundation was noted to be rotting.

Figure 4 - PTW Foundation Rot Prevalent Around Entire Building

The existing PTW foundation has an estimated 25 year lifespan from time of installation, meaning that it is critically overdue for replacement. It is recommended that the existing PTW foundation be replaced with a new concrete foundation as soon as possible. This would include trenching, underpinning and levelling of the entire structure.

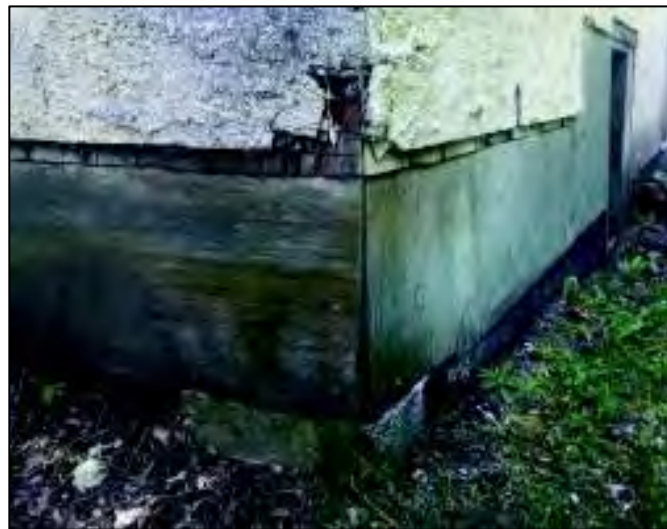
Partial dry rot was noted at the North East corner sill and rim joists (See Figure 5 below), requiring minor repairs to prevent the problem from worsening.

Figure 5 - North East Corner Sill Plate (Dry Rot)

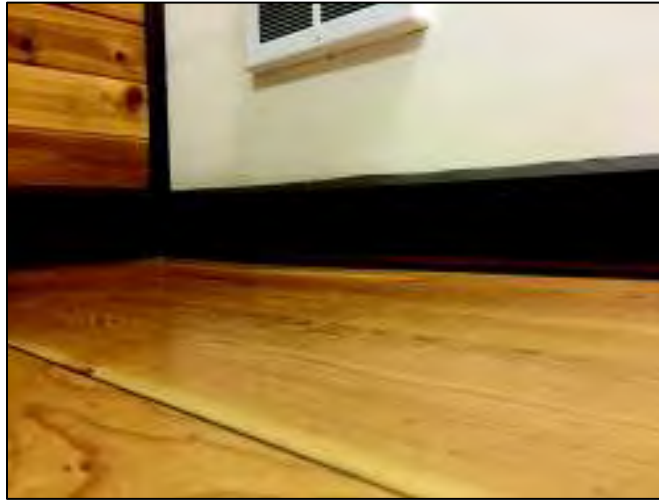
During inspection of the interior building, it was also noted that the floor of the main hall appears to be sloping, indicating deterioration of the foundation below (Figure 6).

Figure 6 - Sloping Hall Floor

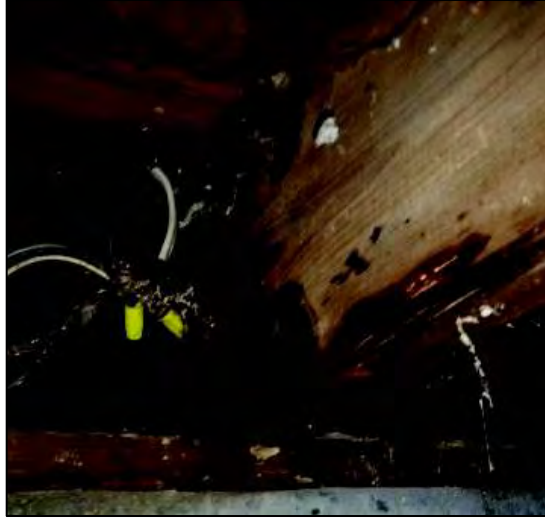
The main concern is the crawlspace has very limited access, which does not allow for detailed inspection or any further work under the building. The sloping main level floor indicates possible hidden moisture damage to the floor structure, and the excessive amounts of moisture present (Figure 7). Figure 7 also shows the electrical work in the basement (no junction boxes) and the sill plate sitting directly on the concrete foundation with no sill gasket. Standing water was visible beneath the building, and ventilation was inadequate and there was no vapour/moisture barrier. The crawlspace vents require wells and covers to prevent moisture intrusion into the crawlspace (Figure 8). Vents should be opened in the summer and remain closed in the winter. In addition, mechanical exhaust fans vented to the exterior of the building are required to reduce the humidity in the crawlspaces.

Figure 7 – Moisture Damage in Crawlspace and Electrical

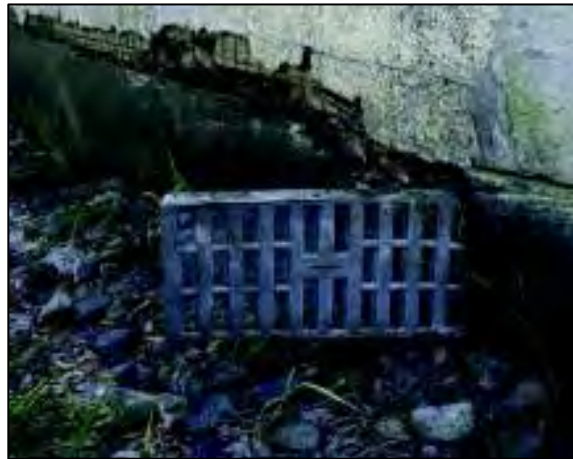
Figure 8 - Crawlspace Vent

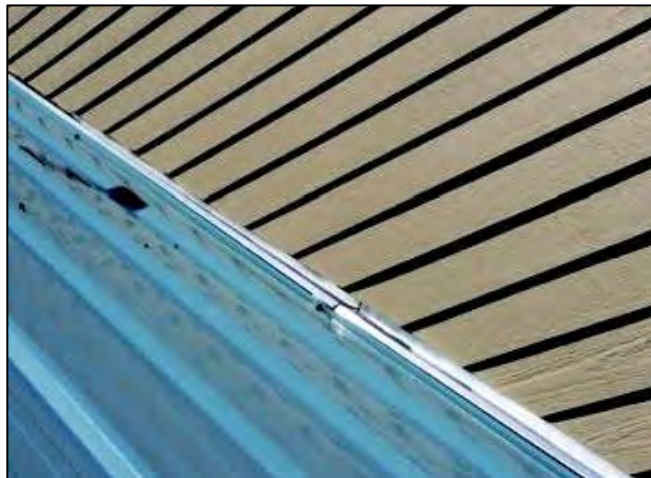
The metal roofing is in very poor condition and should be replaced as soon as possible (Figure 10). There was no visible evidence of underlayment under any of the main roof sections, meaning the building envelope is vulnerable to condensation leaks and moisture penetration, and that installation of the new roofing material will also require installation of underlay. The existing metal roof was not installed correctly, and flashing is not properly preventing infiltration of moisture (Figure 9).

Figure 9 - Flashing at New Building Facade Installed Incorrectly

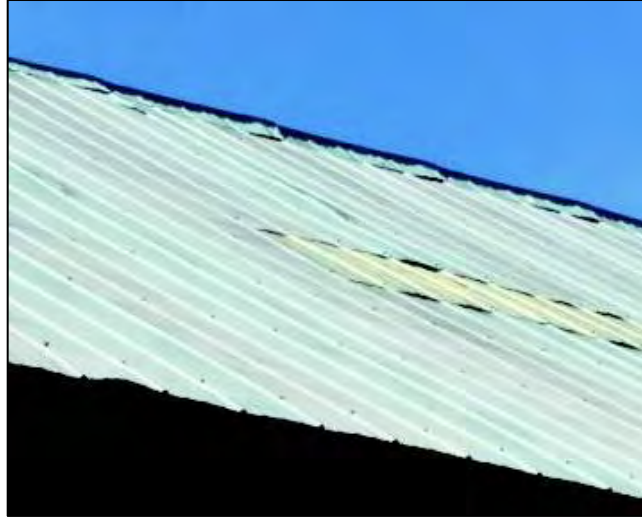
Figure 10 - Metal Roofing

It is recommended that the existing roof truss system be replaced to meet current code requirements. The long term deflection in the existing roof system likely cannot be corrected without compromising the structure. The metal roof should also be replaced, and the entire main roof should be re-sheathed with plywood. Underlayment should be installed, and the roofing should be replaced either with metal sheeting, laminated asphalt shingles, or Malarky shingles. Ice and weather shielding should be installed where applicable. In addition, repairs should be made to the interrupted MBR roofing over the

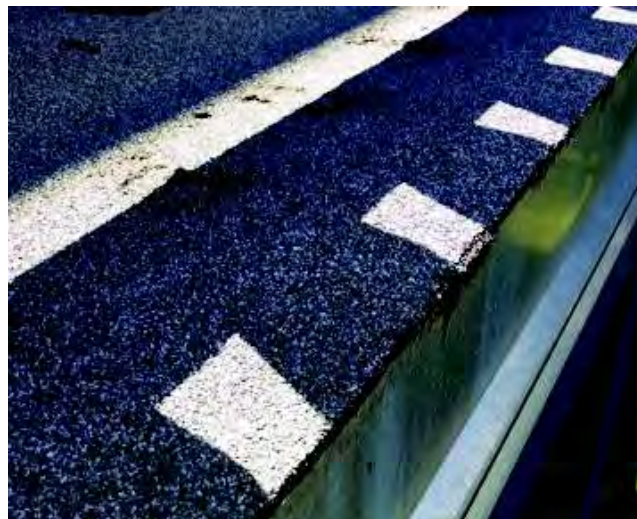
There is also a flat Modified Bitumen Roofing (MBR) roof section over the main entrance to the building (Figure 11). Flashing at this section of the roof appears to have been installed incorrectly (backwards). In addition, the guardrails that were added to this roof section were surface mounted and have compromised the MBR, allowing leaks through to the roof structure to occur.

Figure 11 - MBR Roofing

front entrance where it has been damaged by the guardrail installation. The flashing on the MBR section should also be repaired and replaced where needed.

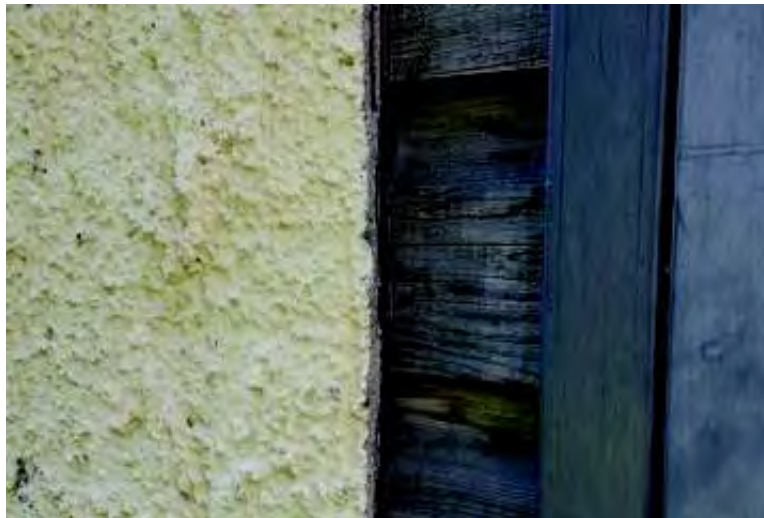
Overall, the exterior walls are in poor shape and all elements require either maintenance or immediate attention. The exterior walls are a combination of wood siding, stucco (Over wood siding) and Hardie Plank exteriors. The wood siding and stucco show significant signs of age, including staining, weathering and rot damage, and loose warped or cracked siding. The wood siding under the stucco appears to be in good condition in some areas (Figure 12).

Figure 12 - Stucco Over Original Wood Siding

- Poorly installed stucco (overtop of shingle/dropsiding) should be removed and replaced.
- Hardie Plank siding installed incorrectly (no flashing at joints).
- Inadequate flashing on West and East walls causing moisture issues. Flashing should be installed or siding should be replaced.

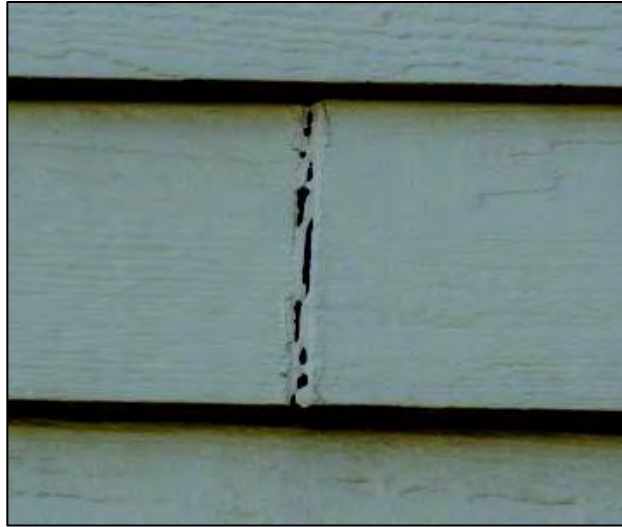
The Hardie Plank siding appears to have been installed incorrectly with no flashing installed at the joints (Figure 13). There are indications of previous cosmetic repairs throughout the exterior walls, which indicates that there are ongoing problems which have not been solved, meaning deterioration will accelerate over time, resulting in higher maintenance costs. It is highly recommended wood siding is replaced and repaired where required instead of covered up. In addition, some of the siding should be removed to determine the extent of the damage to the internal wall structure.

Figure 13 - Hardie Plank Siding Separating @ Joints

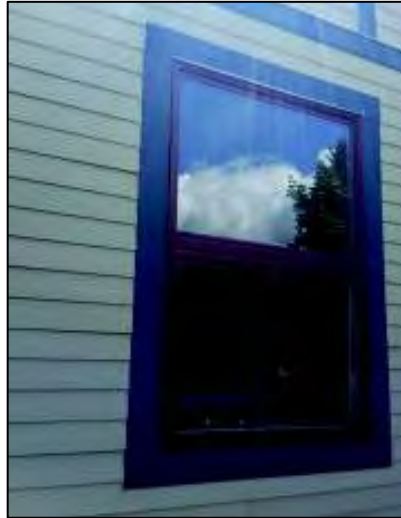
The windows at Bosun Hall are primarily wood framed, and are a mix of fixed and sliding windows with double glazed glass. Overall, the window condition appears to be adequate and does not require significant repairs or replacement at this time (Figure 14).

Figure 14 - West Facing Windows

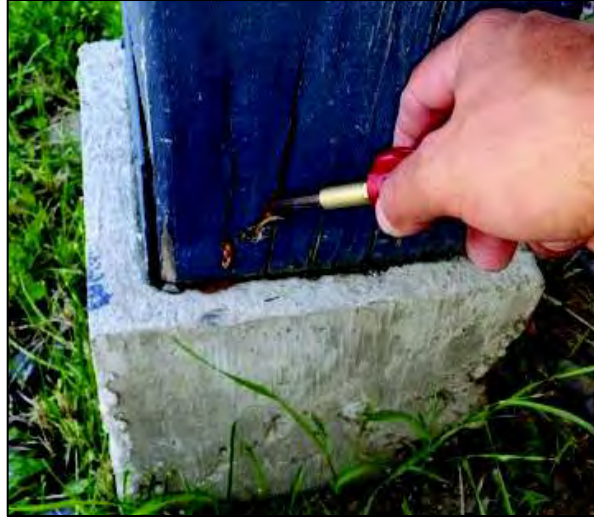
Figure 17 - Dry Rot @ Balcony Post

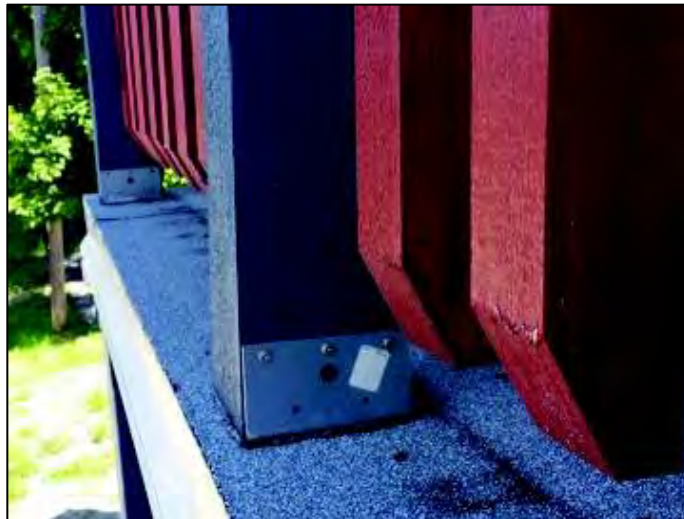
The balcony front entrance is only accessible through windows at the mezzanine level (not intended for occupancy) and is constructed of concrete and wood. It appears to meet code as a roof structure with no access. The structure itself requires some maintenance including the addition of lag screws to saddle brackets, and addition of a perimeter gutter. There is also evidence of potential rot at one of the columns (Figure 17). The guardrails on the balcony are incorrectly installed, as they are currently mounted on the decking. Rails should be correctly installed at the fascia boards (Figure 18).

Figure 18 - Balcony Guardrail

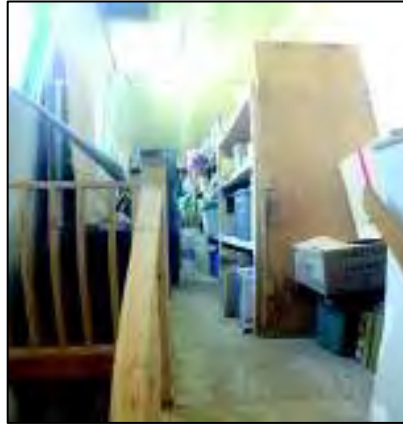
The overall interior of the building is of moderate concern. Normal hairline cracks and slight damage can be seen on walls and ceilings, which can be repaired for aesthetic purposes, but are due to normal settling and slight seasonal shifting of the building. It is recommended that the regional building Inspector view stair rise/run and railings to ensure current code compliance.

Figure 19 - Mezzanine

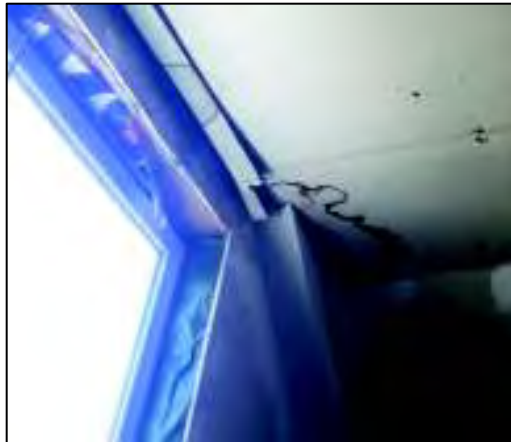
Other aesthetic issues include slight mechanical damage and loose/cracked plaster. Dry water stains were noted on the ceiling in the mezzanine, indicating previous leakage and moisture issues (Figure 20). Damp water stains were noted in the men's bathroom around the toilet area, indicating current and ongoing moisture issues.

Figure 20 - Dry Moisture Stain on Ceiling

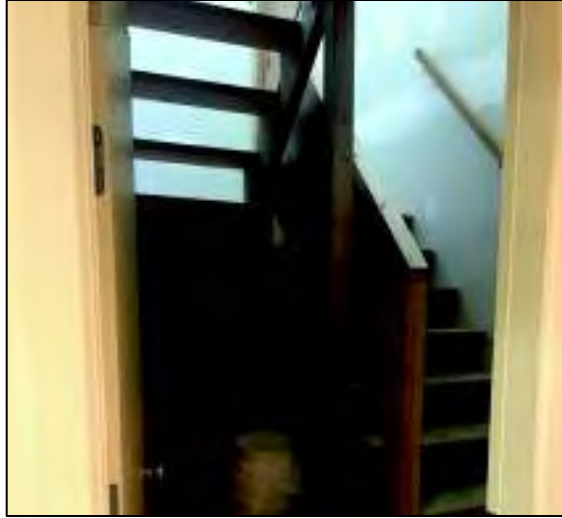
The flooring appears to be in moderately good shape, requiring minor maintenance and refinishing (softwood floor). During the inspection it was noted that the stair railing to the mezzanine area was loose (Figure 21). This is a potential fall hazard, and the railing should be brought up to code standards as soon as possible.

Figure 21 - Stairway to Mezzanine

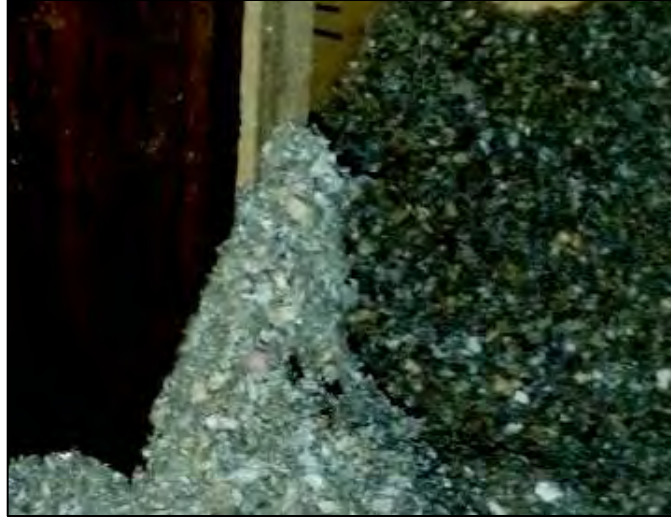
There appears to be a colony of red ants living in the primary attic (above the Hall at the West gable) (Figure 22). This type of ant is not typically destructive; however, the Village may wish to bring in an exterminator. Alternatively, the colony should be monitored to ensure that the nest does not become excessively large, or start to pose risk of damaging the structure. There is also a flicker nest on the south wall of the building.

Figure 22 - Ant Colony in Attic

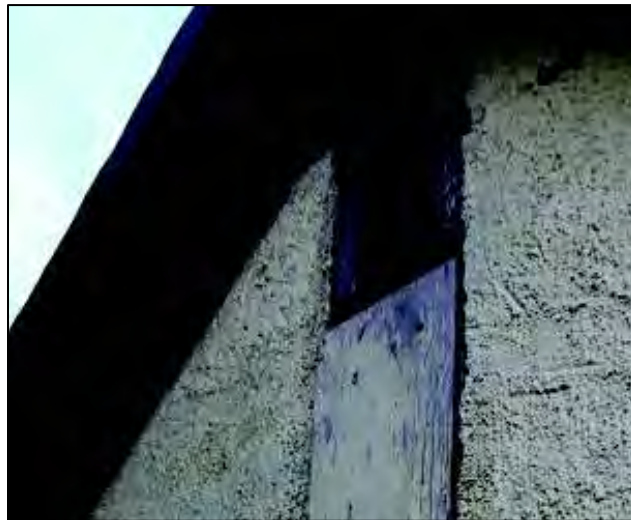
The attics are currently ventilated passively through box vents at the shed roofs and gable vents and ridge vents at the main gable roof (Figure 23). This is inadequate, and condensation issues and moisture were noted in the attic spaces. Increased ventilation through installation of soffit vents are recommended. This would improve air circulation in the attic, and may also help mitigate the potential of ice dam formation.

Figure 23 - Attic Gable Vent

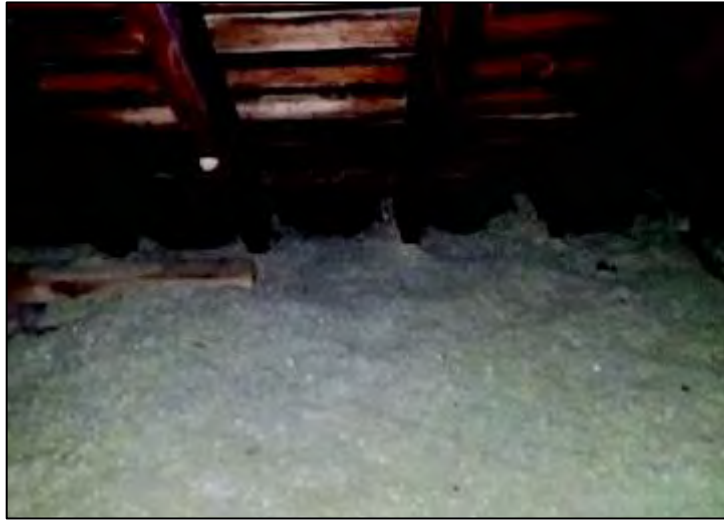
Figure 24 - Insulation Covering Overhangs in Main Hall Roof

Insulation should be moved from roof overhangs when soffit ventilation is installed to prevent insulation from blocking airflow (Figure 24).
