# Village of New Denver Knox Hall Building Assessment

**9dot Engineering Inc.**

***Project Number:*** 15-029

***Prepared for:*** Village of New Denver

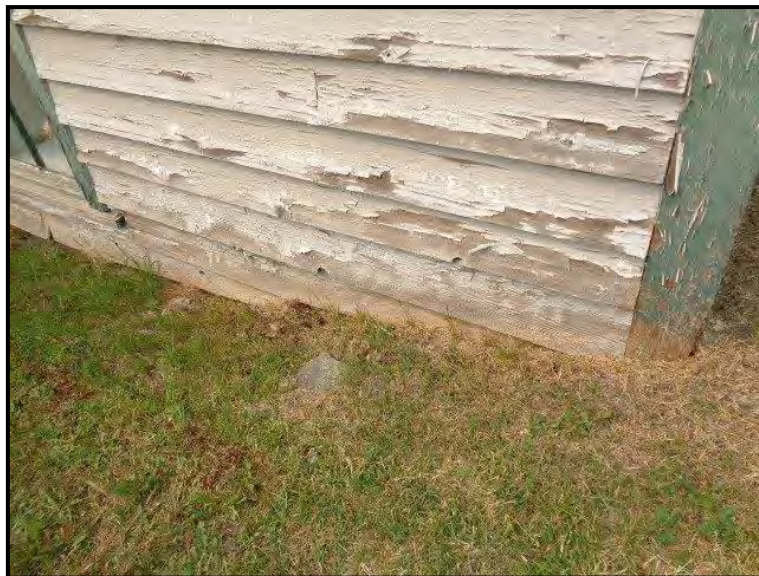
With the exception of the exterior walls, the majority of the structure appears to be intact and requires little to no maintenance or repairs. The exterior walls show significant signs of aging and weathering, and are likely to require maintenance in the near future in order to preserve the structure. The wood frame building shows signs of rot and insect damage, as well as wood to soil contact, these issues have the potential to compromise the structural integrity of the building if not monitored and acted on.

Figure 1 – Exterior Deterioration

The exterior walls are in overall poor shape. The wood siding is very weathered, shows evidence of rot, warping and cracking, and is loose in some areas. There are indications of previous cosmetic repairs, which indicates that there are ongoing problems which have not been solved, meaning deterioration will accelerate over time, resulting in higher maintenance costs. Additionally, the slight overhangs on this building are likely not optimal, leaving the building susceptible to weather damage, water infiltration into the building envelope, and rot. It is highly recommended that the Village of New Denver restore and replace siding as needed. The particular areas of concern include:

- Rear wall shingles rotted.
- Rot at lower east wall. Replace siding with drop siding and fix grade-siding clearance.
- Rear addition exhibits poor building practices and exhibits board and batten siding deteriorating, siding grade clearance insufficient and likely rot.

Condition of the wall stud framing could not be inspected during the site visit. There are visual signs of walls being out of plumb but this is not considered to be a major structural concern at this time, given the age of the building. Further inspection of the wall framing condition is recommended when/if wall insulation is installed.

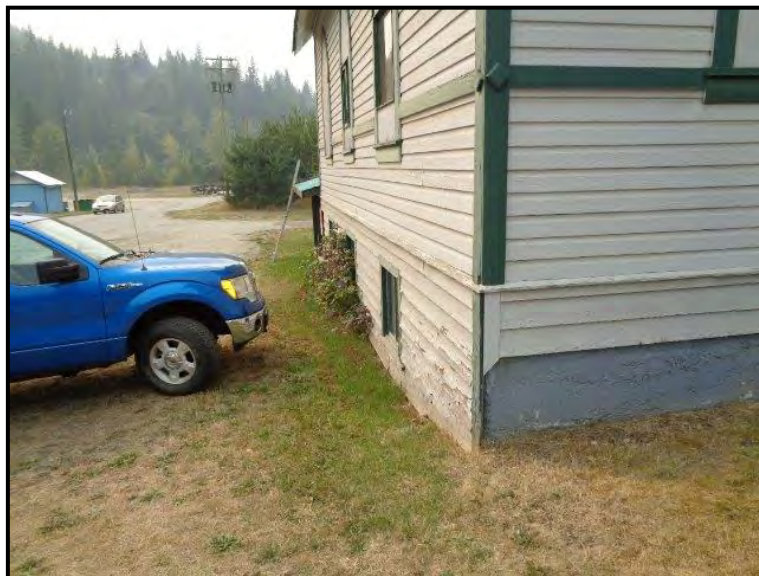
Following the Village of New Denver's purchase of Knox Hall, foundation work was conducted in 1974. This was the most recent foundation work conducted to date, and no detailed information on what was completed is available. The poured concrete perimeter foundation has evidence of minor spalling/deterioration, which is likely due to porous concrete material and freeze thaw cycles typical of the New Denver area. While this may continue to develop into a structural issue, it is presently mainly a moisture concern. As such, it is recommended that perimeter drainage be installed at the foundation wall to prevent further foundation deterioration and moisture issues (See Section 3).

Figure 2 - Foundation @North East Corner

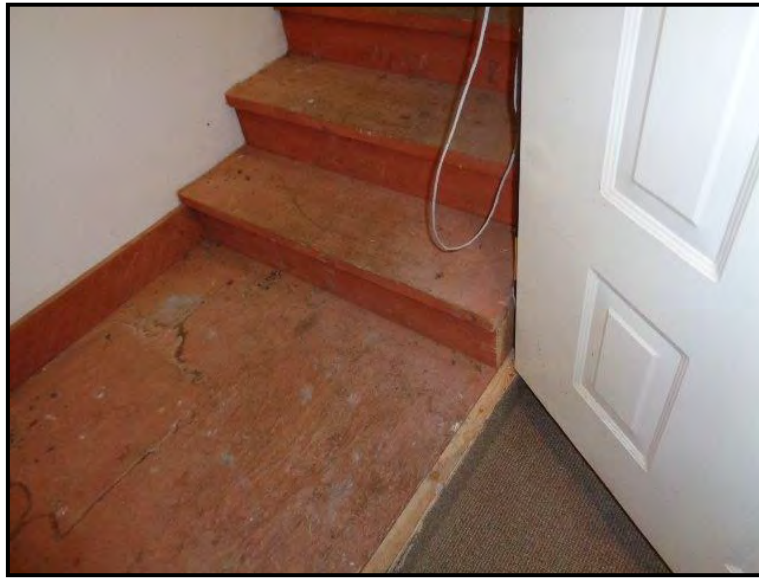
The crawlspace beneath the front porch was not accessible for proper inspection. It is recommended that a hatch be installed to access the area beneath the porch to check for structural issues, and to provide access for repairs of the porch substructure. The basement showed evidence of some moisture damage, but no serious structural issues. At the time of inspection, some stored items in the basement prevented the assessment of some areas and potentially structural elements. Moisture damage was noted, particularly on the wood subfloor of the crawlspace in the Northeast corner and on the wall of the mechanical room. The basement floor was noted to be uneven, which could indicate poor workmanship, rotting subfloor, or uneven settling of the building slab over time.

Figure 3 - Evidence of Moisture in Basement Stairwell

It is recommended that the wood subfloor be removed where possible, as moisture damage is evident. Wall interior faces show some signs of moisture damage (See Section 2.j).

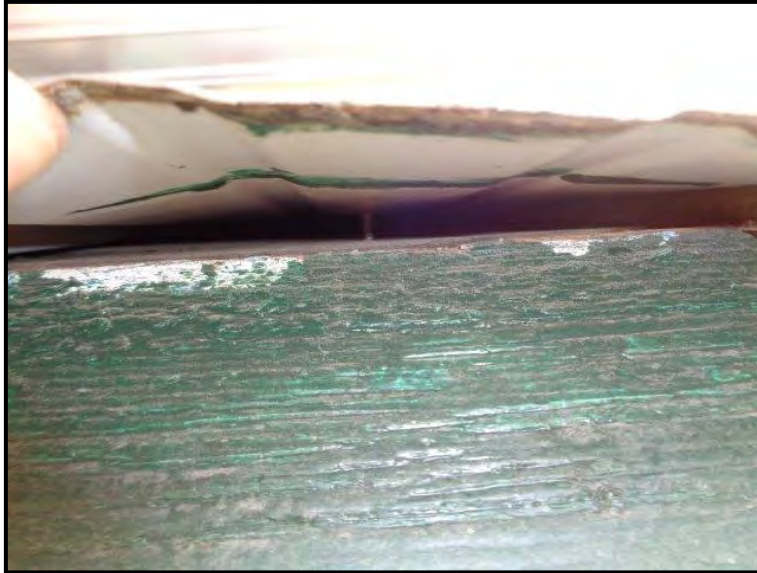
Only the rear porch roof was accessible for “on roof” inspection due to the steepness of the main roof. The metal roofing material appears poorly installed with a few notable leaks. Underlay appears to be missing or only partially installed, meaning that any moisture that gets under the metal sheets can cause damage to the roof structure beneath. It is recommended that the Village of New Denver plan to replace the metal roof and to complete the underlay below. For further information on the roof’s structural condition, please see Section 2.g.

Figure 4 - Roof Missing Underlay, Some Missing/Loose Fasteners

Replacement of missing/loose fasteners is recommended if the roof is not replaced. Flashing details at the chimney and exterior walls is incomplete and should also be repaired and replaced as needed.

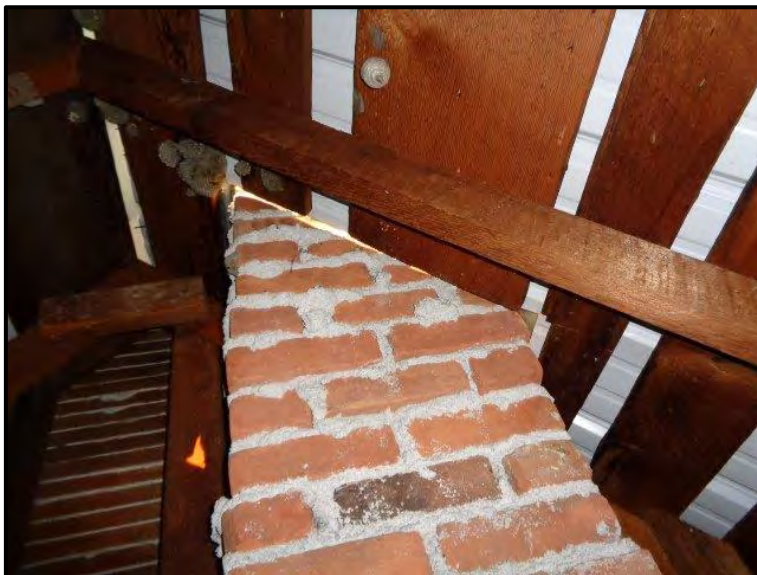
Knox Hall has one (1) brick chimney that appears to be unlined. The interior of the chimney and flue was not inspected at the time of this assessment. The existing chimney requires several minor repairs including some masonry repairs, a new chimney cap, and the flashing replaced. These actions will help reduce moisture and water infiltration into the building.

Figure 5 - Poor Flashing and Weather Sealing of Chimney

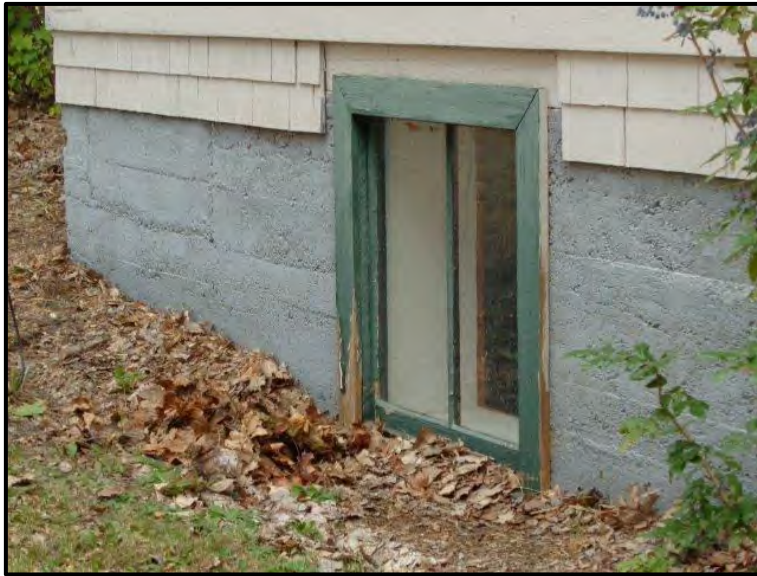
Figure 6 - Aging Lower Level Window

Windows were last replaced in 1977, and replacement of the majority of exterior windows is recommended, as well as the installation of windows into old window casings that are currently not in use. Most windows exhibit evidence of condensation, damaged trim and sills etc. or are inoperable. New windows, and new window installation will improve the building envelope, leading to lower heating bills, and improved moisture management. Functional windows will also allow natural ventilation of the building when desired.

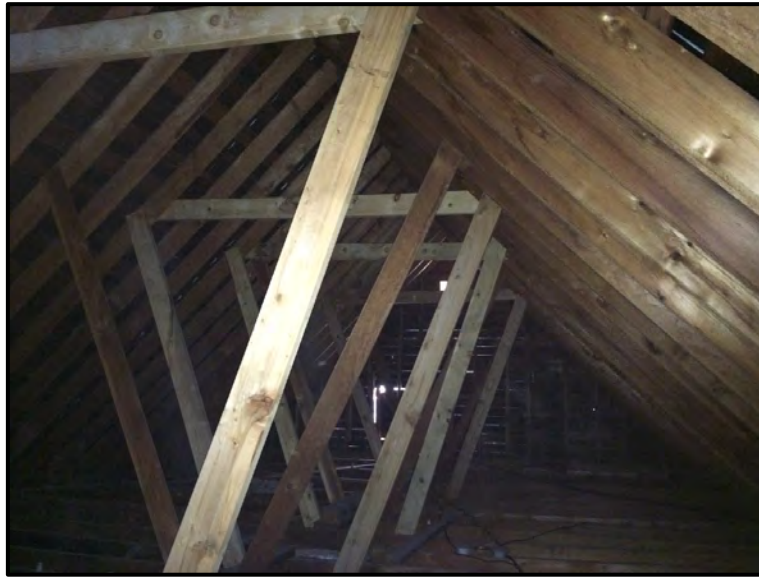
Sag in the existing joists was noted; however they appear to be in solid condition upon visible inspection. The aging roof cannot currently carry the expected snow load for the area. As such, it must shed the snow load, and so The Village of New Denver must continue to use metal sheet as the roofing material for the building in order to help the structure shed snow weight. Additionally, eaves troughs/snow anchors must not be installed, as they would increase the snow load on the structure.

Figure 7 - Roof Structure

Reinforcing actions should be taken to add additional support to the existing roof structure including plywood gusset plates at the ridge of the roof, and additional collar ties above the existing collar ties to reduce further sagging of the roof.

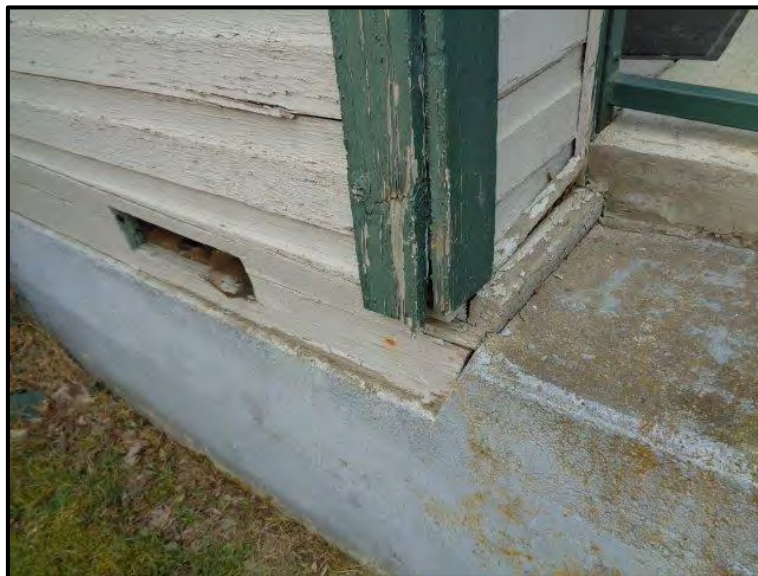
The small front deck and ramp has settled away from the structure with time, causing possible leaks into the crawl space below, which may lead to rot and deterioration. At this time, it is difficult to determine the condition of the lower structure, as the crawlspace is not accessible. As a result, it is highly recommended that crawlspace access be installed from the existing crawlspace to allow evaluation and eventual repairs of the lower deck structure, which is likely to have structural issues, indicated by rot at the joint between the concrete walkway and the wood frame wall. A screen should be placed over the hole to the crawl space under the front deck (Figure 8) to prevent animals and debris from entering. Some aesthetic issues that the Village of New Denver may wish to remedy include replacing the trim and rot damaged wood components of the deck. The elevated walkway leading to this deck is in good condition and does not require immediate attention.

Figure 8 - Front Deck

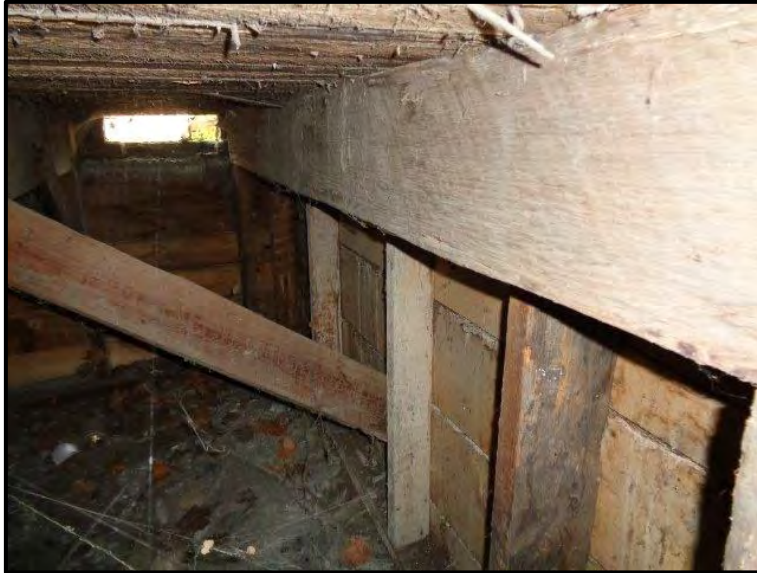
Figure 9 - Front Deck Crawlspace

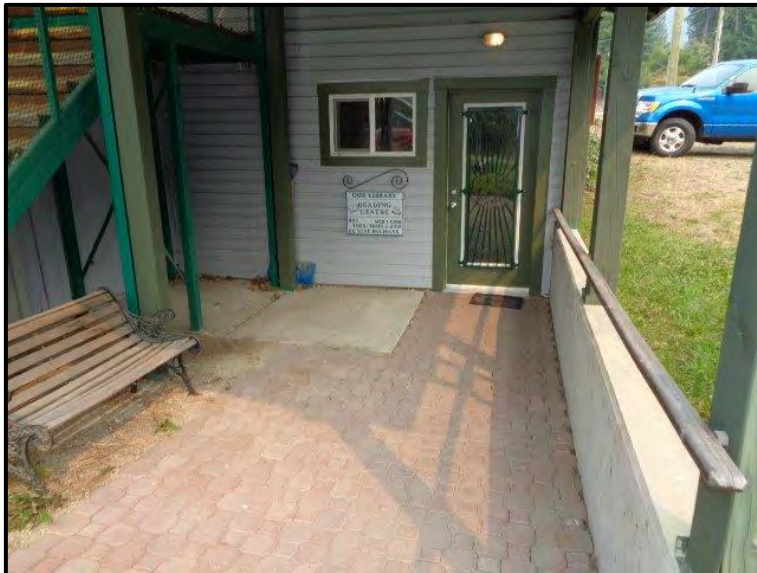
Figure 10 - Back Deck

The larger back deck should also have a drain installed in the pavers near the library door, to prevent moisture intrusion to the basement during heavy rain events. The Southeast post shows some signs of damage and misalignment, and should be realigned. Overall, the back deck is in good condition.

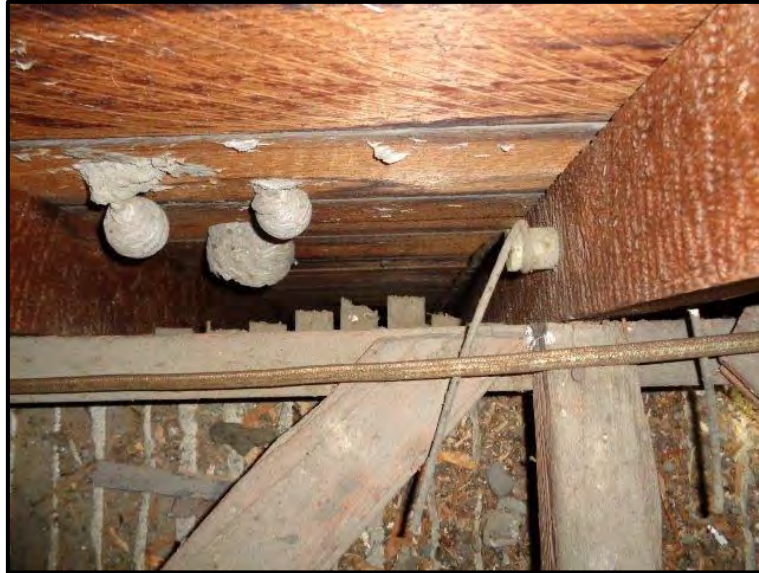
Leaks were noted in the roof sheathing. Evidence of past moisture in the attic was noted; however, the area was dry at the time of inspection.

Figure 11 - Wasp Nests Noted in Attic

Evidence of previous wasp/bee nests was noted in the attic. If users of the building note these pests to be a nuisance, a pest control company should be contacted.

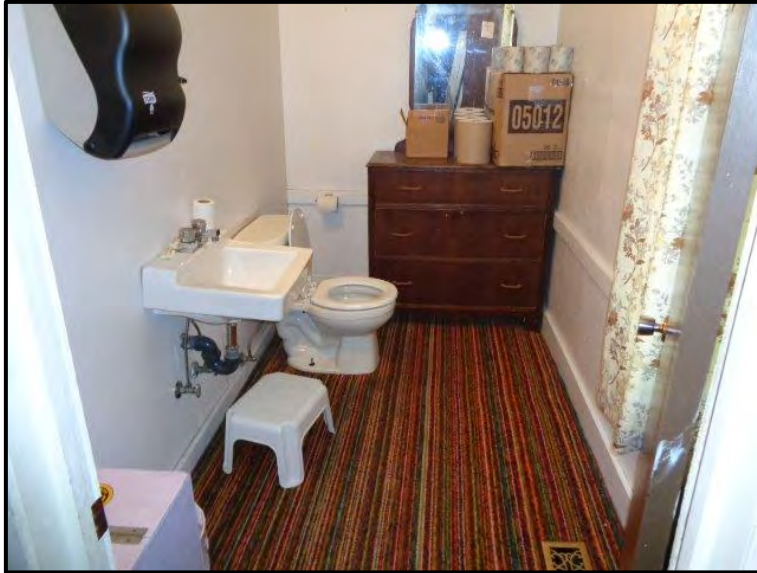
Figure 12 - Carpeted Bathroom with Poor Ventilation

The main floor bathroom requires improvements to the existing ventilation system. It is recommended that a vent be installed in the exterior wall with a 30-minute timer. A heat source should also be provided for this bathroom (see Section 2.m). The existing wall hung sink is slightly loose and should be secured to the wall.

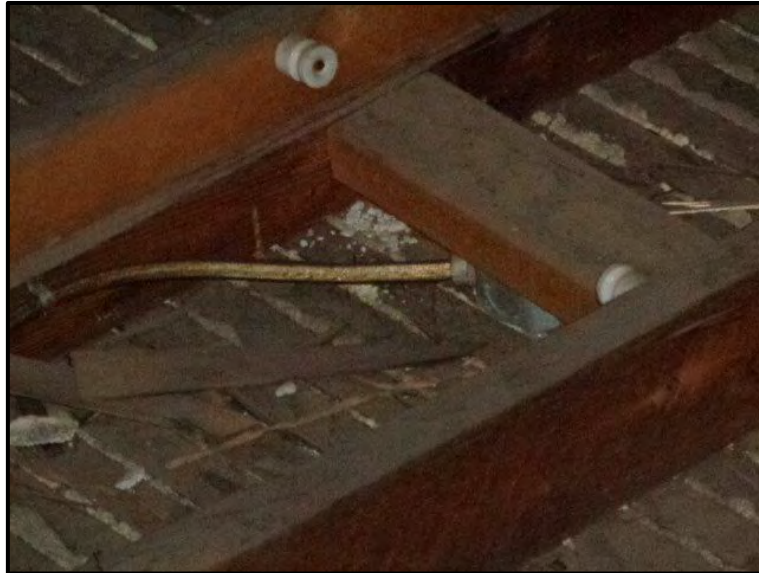
The electrical system in Knox Hall appears to be in good working condition, with room for expansion to the system and there is some evidence of recent upgrades to the system. There is exposed wiring around the lower exterior walls which should be covered and/or protected. During the site visit, items being stored in Knox Hall prevented the testing of some outlets and switches; however, the switches and outlets that were tested appear to be serviceable. There is some existing knob and tube wiring in the attic that appears to have been disconnected.

**Figure 13 - Disconnected Electrical in Attic**

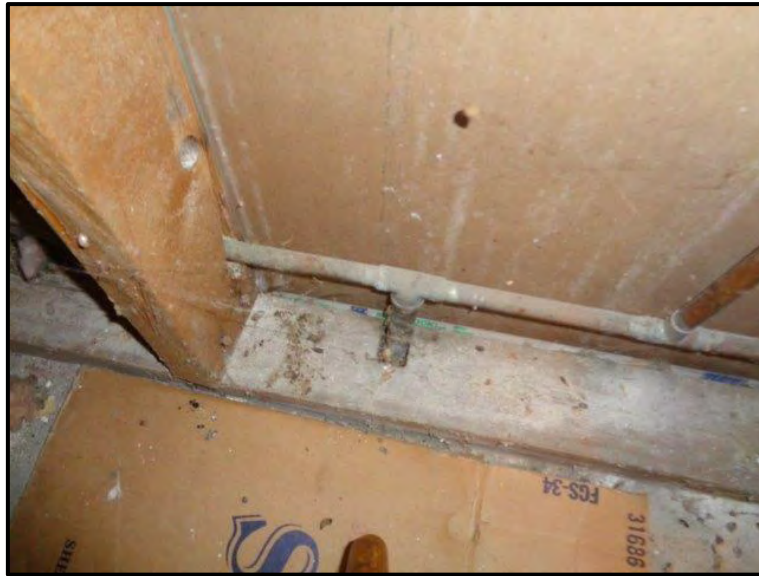
Overall, the plumbing system within the building is functional, with a leak apparent at the kitchen sink that should be repaired. One main issue with the plumbing system is the lack of shut off valve where the water enters the building. It is highly recommended that a shut off valve be installed as soon as possible, along with a PRV (pressure reducing valve). It is also recommended that the existing galvanized steel service pipe be replaced as a proactive measure.

Figure 14 - Water Service Pipe

A slab drain should be installed in the crawlspace and in the mechanical room where the hot water heater has been installed. A hose bib for the exterior water supply is also recommended, but is not urgent.
