**MITIGATING THE IMPACT OF STORMWATER RUNOFF
ON NEW DENVER'S DOMESTIC WATER SUPPLY
WELLS**

Prepared for the Village of New Denver

JUNE 2004

**RE: MITIGATING THE IMPACTS OF STORMWATER RUNOFF ON NEW DENVER'S
DOMESTIC WATER SUPPLY WELLS**

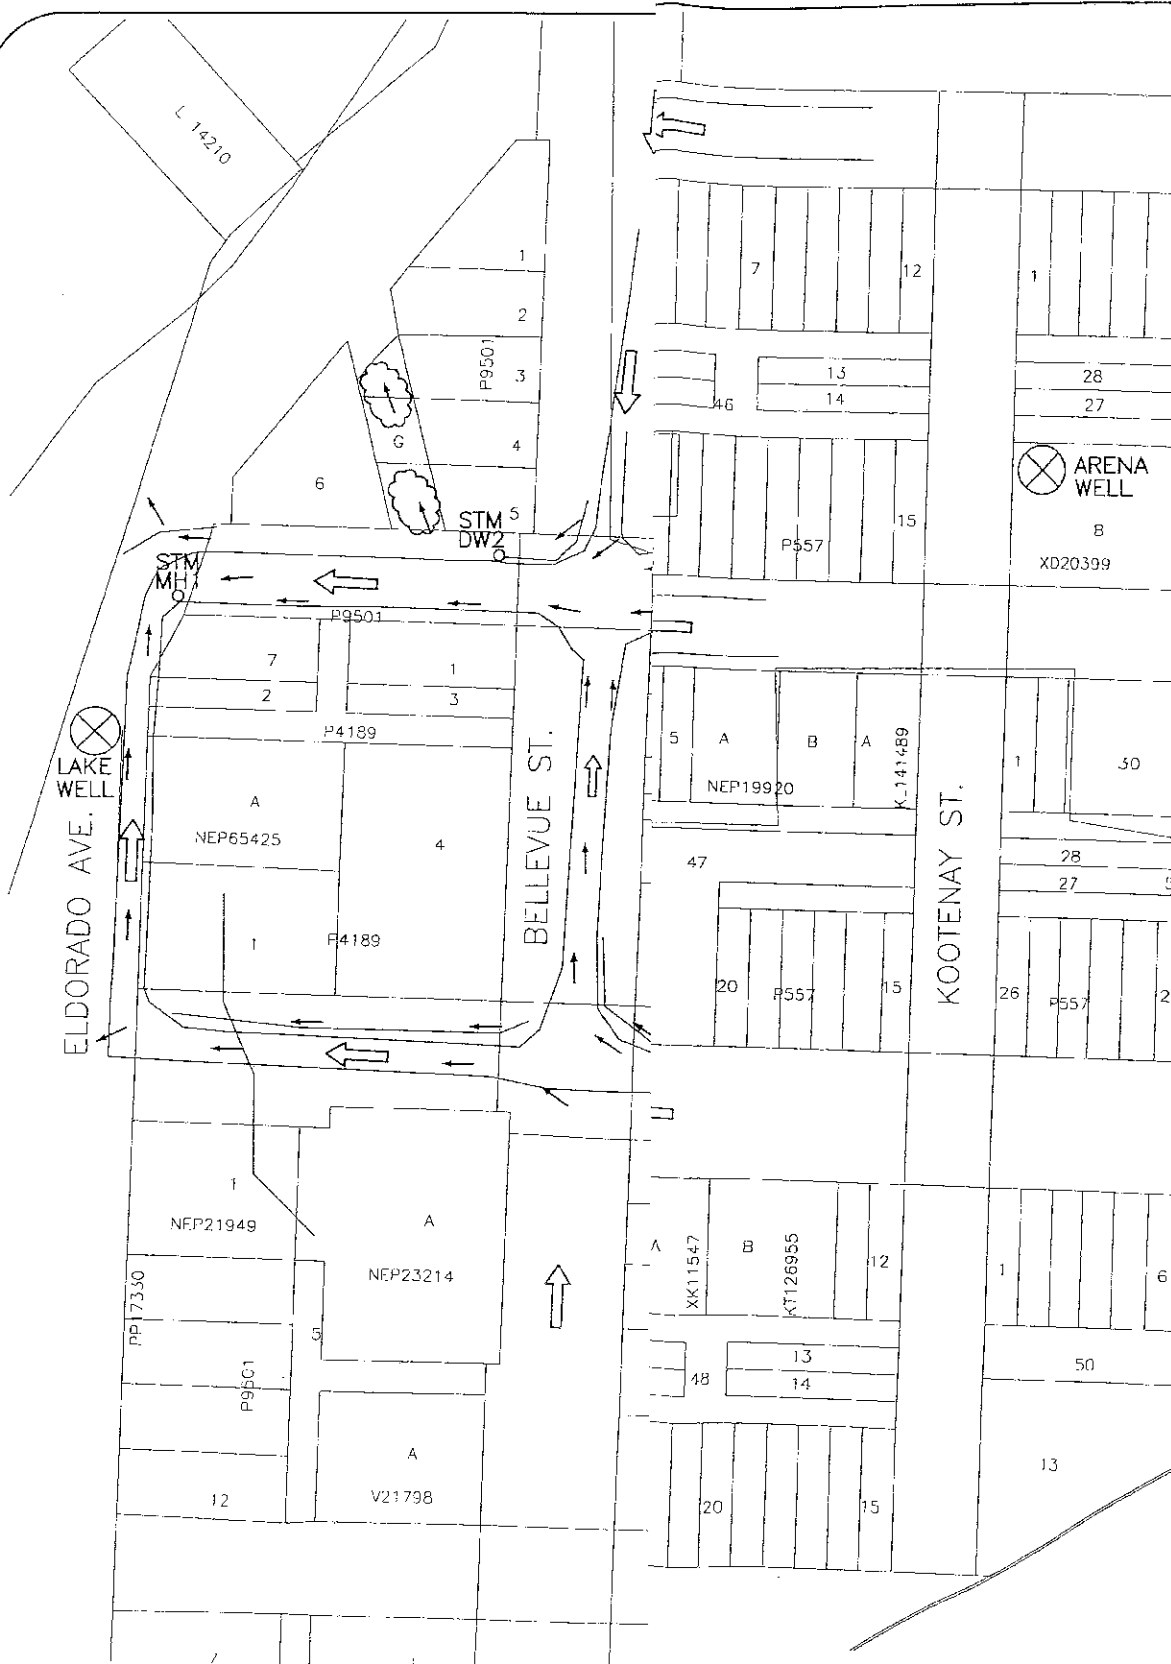
ALL SITE PLAN & DRAINAGE

An inventory and inspection of the existing drywells was completed in June 2004. Drywell numbers can be referred to in the site plan of *Figure 1*. Drywells are generally constructed using one or two sections of precast perforated concrete with a solid section on top. The solid section has an open grated cover. Each section is about four feet in diameter and about three feet deep. Each perforated section contains five rows of perforations. The inspection revealed varying amounts of sand and silt deposited in the drywells, which block the perforations and reduce the effectiveness of runoff infiltration. A summary of the drywell inventory is given in *Table 1* on the following page.

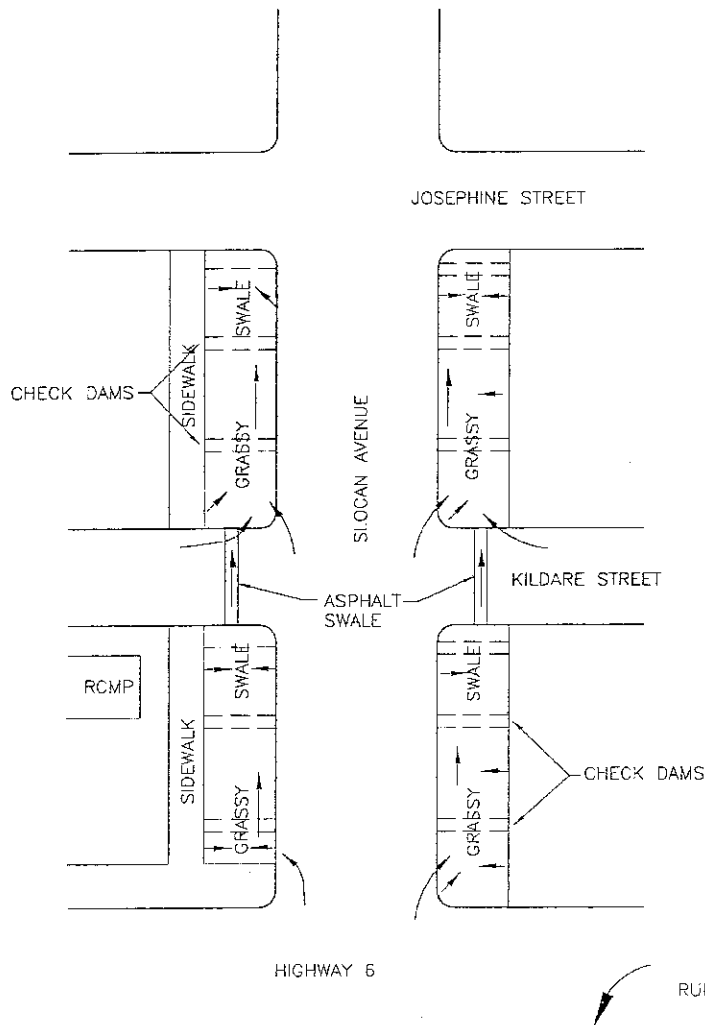
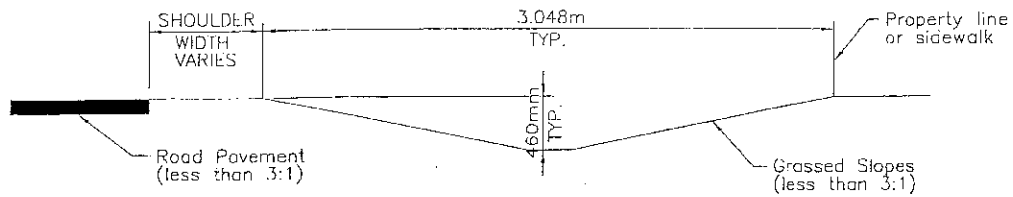
GRASSY SWALES ON SLOCAN
AVENUE & TYPICAL SECTION

and increasing infiltration near the point where rainfall hits the ground. Slocan Avenue already contains some grassy swales on the boulevard and these could be improved and expanded. Some of these grassy shoulders slope towards houses, however, causing potential flooding problems and some do not have a consistent slope down the street.

Grassy swales remove pollutants from stormwater by slowing the water and settling or filtering out solids as the water travels over the grassed area, and by allowing infiltration into the underlying soil. Maintaining a low velocity and shallow depth are key design criteria. Check dams can be added to increase runoff detention and infiltration. A grassy swale designed with a low bottom slope and check dams can remove up to 40% of suspended sediments, phosphorous, nitrogen, and oxygen demand from the runoff. **Figure 2** shows a layout plan and a typical cross-section for the proposed grassy swales.

Grassy swales should be constructed with the following guidelines:

- Relatively flat side slopes (3 to 1)
- Vegetated sides and bottom
- Contains contiguous areas of water only following rainfall
- Accessible for regular maintenance (mowing)

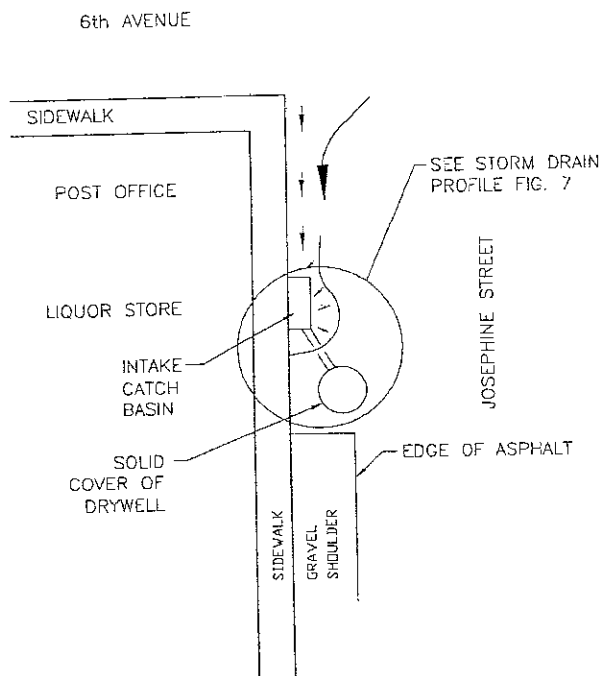
UPGRADE FOR DRYWELL #3

#3	West side of Josephine St. in front of liquor store	Filled with sand and silt to a depth of 89 inches. One section of perforated concrete is visible with 5 perforations showing. Intake cover is in an asphalt depression and is partially clogged with debris. During high flows, stormwater may flow past the intake causing yard flooding below.

We recommend that an intake catch basin be installed for drywell #3 in order to keep the sand and silt from entering. The catch basin is then easily cleaned when necessary. The catch basin should be installed in an asphalt depression and/or gutter in order to facilitate runoff collection. The drywell cover should be solid. **Figure 3** shows a detail of this upgrade to drywell #3.

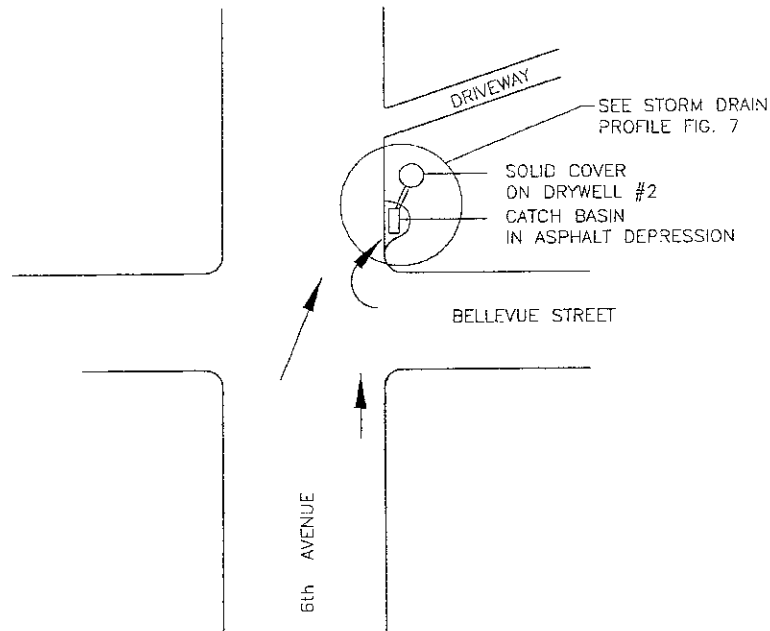
UPGRADE FOR DRYWELL #2

#2	North side of 6 th Ave. just west of Bellevue Ave.	Consists of 1 solid concrete section and 1 perforated section. Filled with sand and silt to a depth of 40 inches with no perforations showing. Non-functioning. Stormwater flows down adjacent driveway to Slocan Lake. Intake cover is in a gravel depression on the road shoulder and is often blocked with leaves and sand.

Drywell #2 currently is not functioning due to the amount of sand and silt inside it. It was constructed in an area containing layers of black silty soil with poor drainage characteristics and does not effectively exfiltrate the stormwater even when not filled with sediment. We recommend that a new drywell consisting of two perforated concrete sections be installed in a nearby location where better draining soils are present. An intake catch basin should be installed in an asphalt depression for collecting the runoff and keeping debris and sediments out of the drywell. *Figure 4* shows a detailed sketch of the upgrade to drywell # 2.

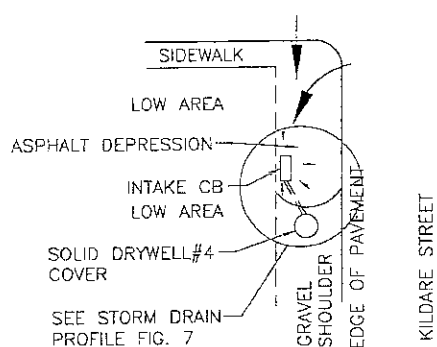
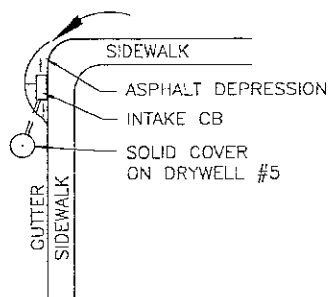
UPGRADES FOR DRYWELLS
#4 & #5

#4	West side of Kildare St. just South of 6 th Ave.	Filled with sand and silt to a depth of 102 inches. 1-½ sections of perforated concrete are visible with 8 rows of perforations showing. Intake cover is located in a gravel depression on the road shoulder. Appears to be functioning adequately at present.

#5	East side of Kildare St. just south of 6 th Ave.	Filled with sand and silt to a depth of 88 inches. 1-¼ sections of perforated concrete are visible with 6 rows of perforations showing. Intake cover is located in an asphalt depression and was totally blocked with debris at the time of inspection.

Drywell #4 is located in a gravel shoulder and is partially filled with sediment. It appears that stormwater runoff sometimes flows past the intake cover and down into low-lying areas of the yard to the west. We recommend that the drywell be cleaned out and an intake catch basin be installed nearby in an asphalt depression. *Figure 5* shows a detailed sketch of this upgrade.

Drywell #5 is located in an asphalt depression and contains a large amount of sand and silt. It appears that this drywell is subject to a high sediment load and the intake is often blocked with debris. We recommend that the drywell be cleaned out and an intake catch basin be installed in the gutter nearby.
