BENCHMARK ENVIRONMENTAL SERVICES

Ecosystem Restoration Plan

New Denver, BC

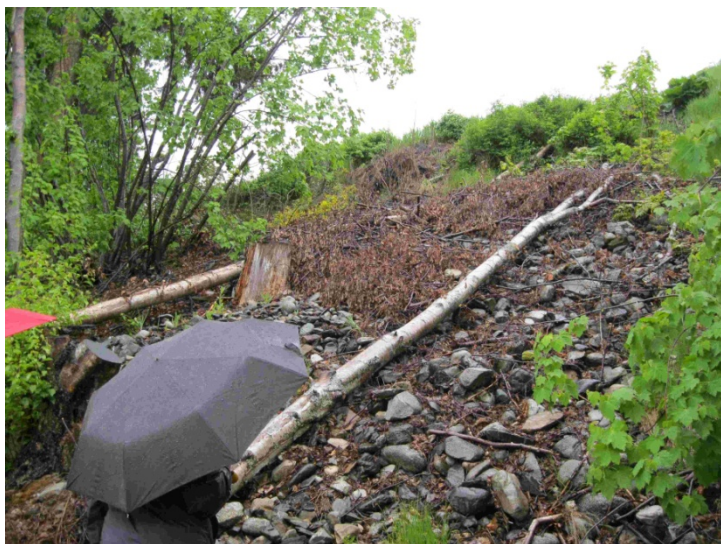
There are two degraded areas within the site, and therefore two treatment units. The first treatment unit (TU1) is located in the middle of the site on the slope and is approximately 900 m² in size. Over the past few years, mature trees have been cut on the site which has generated an invasive weed response and some erosion. Invasive weeds are primarily orange hawkweed (*Hieracium aurantiacum*) and St. John's wort (*Hypericum perforatum*). Also of concern is the fact that residents have been using the open patch to dump yard waste which has enabled the growth of domestic species such as common lilac (*Syringa vulgaris*) and rhubarb (*Rheum rhabarbarum*).

Figure 1: Treatment Unit 1, Bellevue St

- 1.1 Plant native shrub species on both treatment units which are found in healthy stands of ICH dw 01a stands and also provide habitat value for songbirds. See table 1 for a list of recommended species.

1.2 Plant native trees which grow naturally in the ICH dw 01a but obstruct views to a lesser degree than Douglas fir. Paper birch is the recommended species for TU2. A mix of species listed in Table 1 is recommended for TU1.

2.1 Concentrate planting of larger shrubs (Saskatoon berry and mock orange) in areas where the canopy is open and invasive species are thriving. This will provide competition and shade to invasive species which are shade intolerant.

3.1 Plant conifers in areas where erosion is evident as the root systems will stabilize the slope over time.

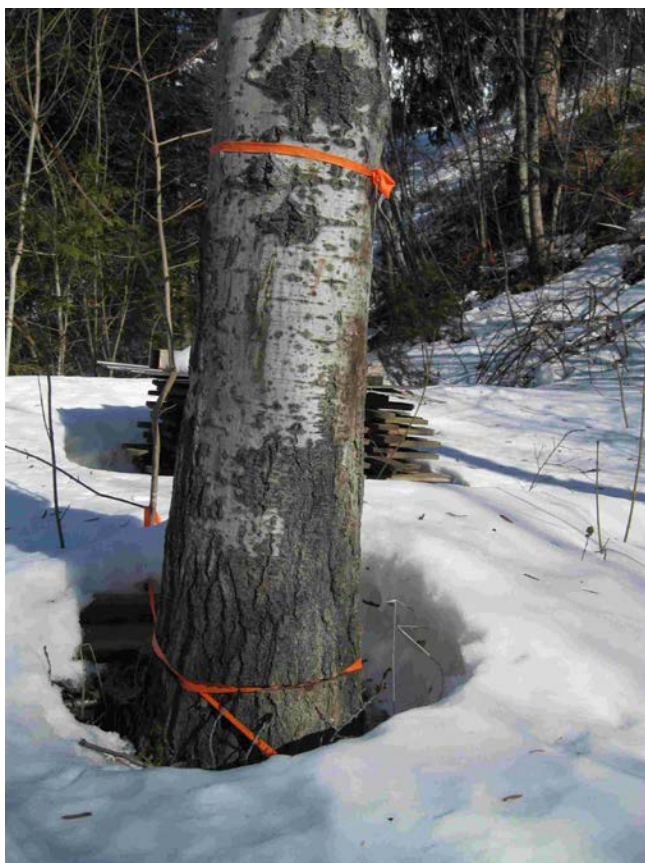
The second treatment unit (TU2) is located at the south end of the site on a small, flat area approximately 400 m² in size. This treatment unit was previously a healthy stand of aspens which were girdled in the fall of 2010 and removed by the village in the spring of 2011. Similar to TU1, the opening of the canopy has also generated a weed response consisting primarily of orange hawkweed.

Figure 2: Girdled tree on Treatment Unit 2, February 2011

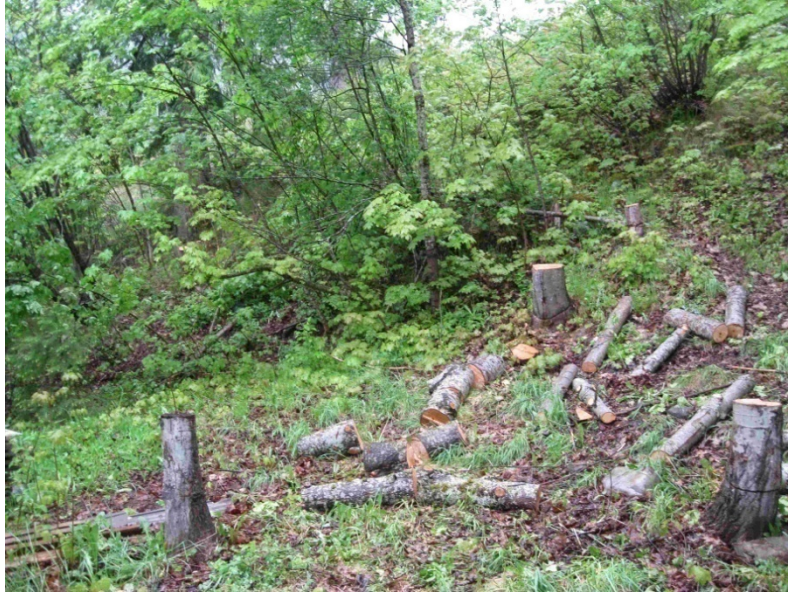
Figure 3: Treatment Unit 2 after girdled trees were removed, spring 2011.

2.2 Plant deciduous trees in the open areas as they will provide shade in the summer when it is most needed to shade out invasive species.

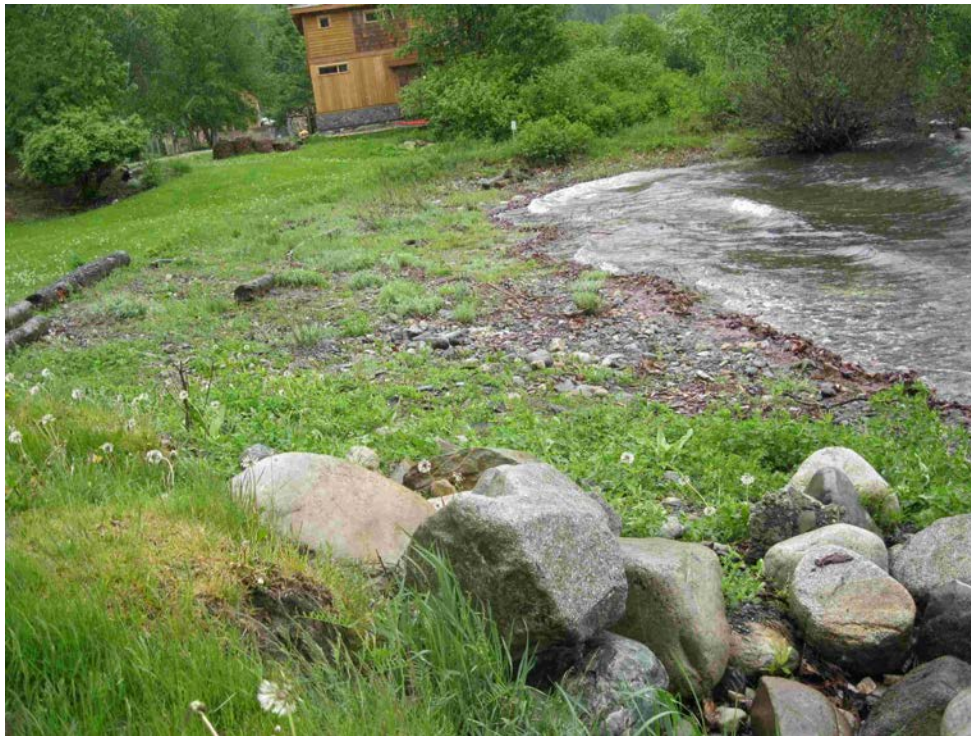
exposed to strong winds off of the Slocan Lake. This treatment area is situated at 545 m elevation. It is also classified under the BEC system as ICH dw 01a. The site is characterized as a shallow bay bordered (at low water) by a beach composed of cobble. It is mostly under the high water mark and so the vegetation must be tolerant of seasonal fluctuations in the water level.

The site is bounded by the Kohan Reflection Gardens on the north side, residences on the east side and an RV park on the west side. It is used by the public on a daily basis and is therefore subject to public safety concerns. During the summer of 2009 a wind storm blew down several black cottonwoods which damaged an RV and created a major public safety concern for Village of New Denver staff. Subsequent to this event the Village of New Denver had more black cottonwoods removed and there has been some erosion in the foreshore area.

There are invasive plants populating the foreshore including (but not limited to) curled dock (*Rumex crispus*), chickory (*Cichorium intybus*) and spotted knapweed (*Centaurea spp.*). While this infestation is currently relatively small, it represents a seed source of invasive plants that threaten the integrity of surrounding foreshore areas.

Figure 4: Kohan Reflection Garden treatment area facing east, May 2011

- 1.1 Hand pull invasive weeds on the foreshore area and replace with native riparian shrub species. The presence of shrub species will shade out seedlings generated by the seed bank left behind by invasive weeds.

- 2.1 Plant a mix of shrubs listed in Table 2 in a way that provides connectivity to the healthy, native edge of shrubs already present on the east side of the site.

- 3.1 Pocket plant stones on the west side of the site with shrubs listed on Table 2.
- 3.2 Seed bare mineral soil in eroded areas with Teck Riverside Reclamation seed mix (available through Quality Seeds West, Langley BC) to outcompete invasive weed seeds. This seed mix was developed for riparian restoration projects in the BC Southern Interior, specifically the West Kootenays.

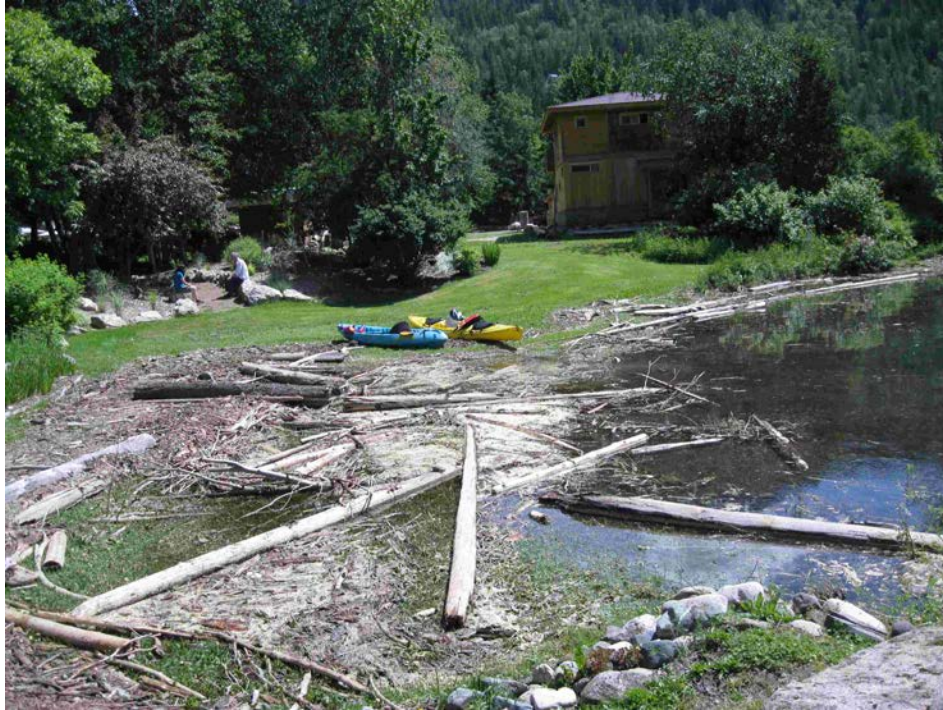
Figure 5: Kohan Reflection Garden treatment area at full pool, June 2011

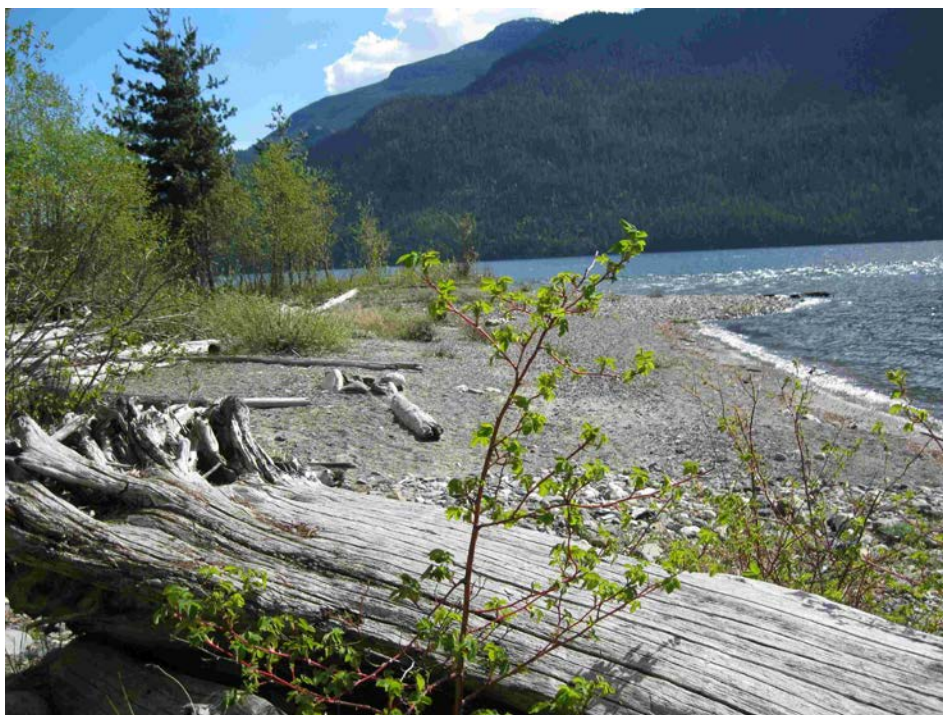
Figure 6: Reference ecosystem site, Roseberry BC

A reference ecosystem was used in conjunction with the BEC system to generate a list of recommended plants for this treatment area. The reference site (located in Roseberry BC) is situated on an alluvial fan 5 km NW of the Kohan Reflection Gardens. The elevation on the reference site is 550m. The aspect is slightly more west facing than that at the Kohan Reflection Garden. The reference site is flat and composed of a healthy mix of native vegetation. Dominant shrub species include Saskatoon berry (*Amelanchier alnifolia*), Nootka rose (*rosa nutkana*), Red osier dogwood (*cornus stolonifera*), Willow (*salix spp.*), soopolallie (*Sheperdia Canadensis*), sitka alder (*Alnus crispa*), common snowberry

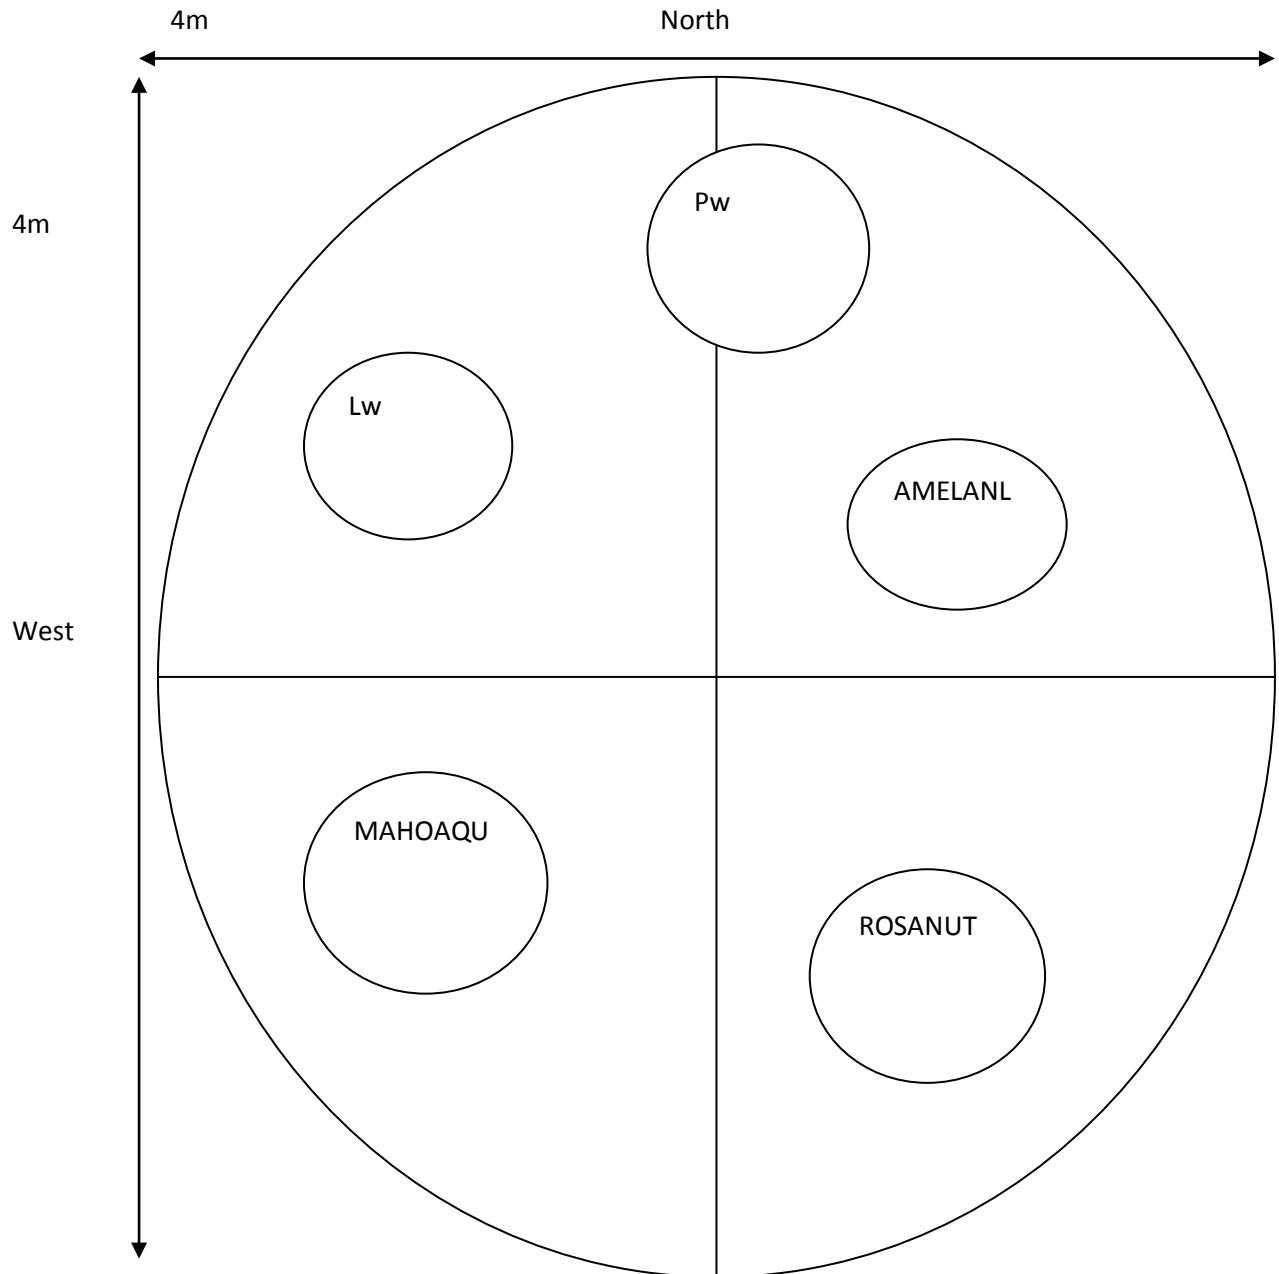
Appendix 3: Example of Proposed Plot Sketch Design

Routine evaluation of the plants can be done in conjunction with maintenance activities during the first growing season. In order to facilitate monitoring and maintenance, trees and shrubs will be planted in groups of 5. This will result in 16 groups of 5 plants each. A 10' galvanized nail complete with washers, identification tags and flagging tape will be placed in the center of each group. These nails will mark the plot centers. A Global Position System (GPS) will be used to identify the coordinates for each plot center. The plots will be 16 m² in size. When the plots are planted, crews will sketch the layout of the plantings

(with the assistance of an Environmental Technician) noting the position and species of plants within the plots.

During the second season, volunteers will continue walking through the restoration site on a bi-monthly basis during the growing season to perform the routine evaluations. By this time, maintenance activities should no longer be required. At the end of the second season, an Environmental Technician will revisit the plots with the original sketches and note the condition of each plant, recreating the sketches for comparison.

At the end of the third season, an Environmental Technician will repeat the process of checking on the plots and re-sketching them. The Technician will then submit a short report summarizing the plot sketches cross-referenced with the spreadsheet data which will quantify the survival of the planted material and make recommendations for future restoration efforts. It is recommended that a bird survey also be performed during the third season to determine if the restoration objective of restoring habitat for songbirds has been met.
