Floodplain Mapping Report

Village of New Denver

March 2025

Project No. 1479-111

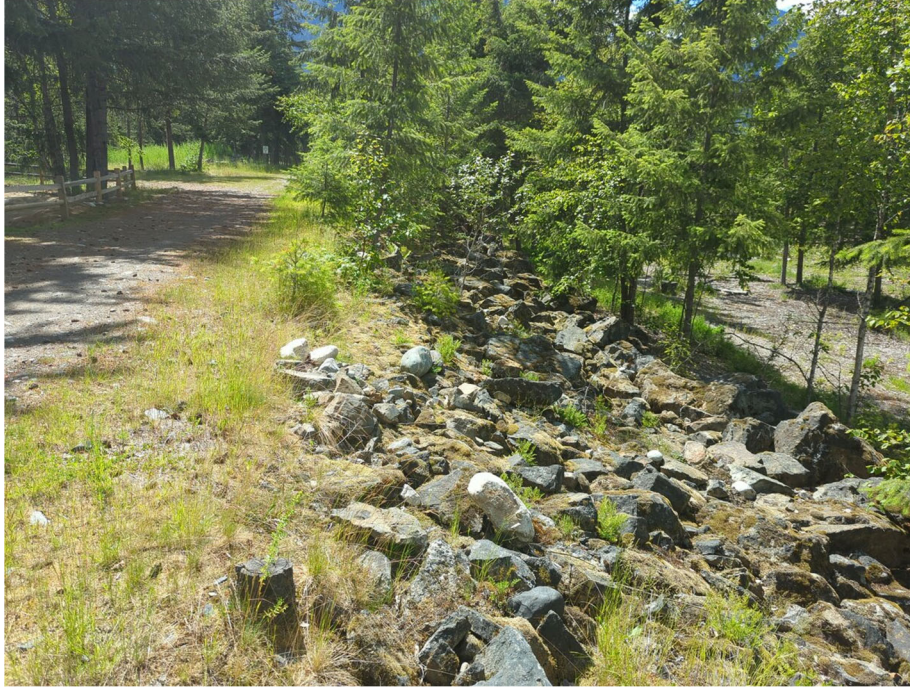
FIGURE 2-1: EXISTING DIKE CONSTRUCTION POST 1973 FLOOD EVENT

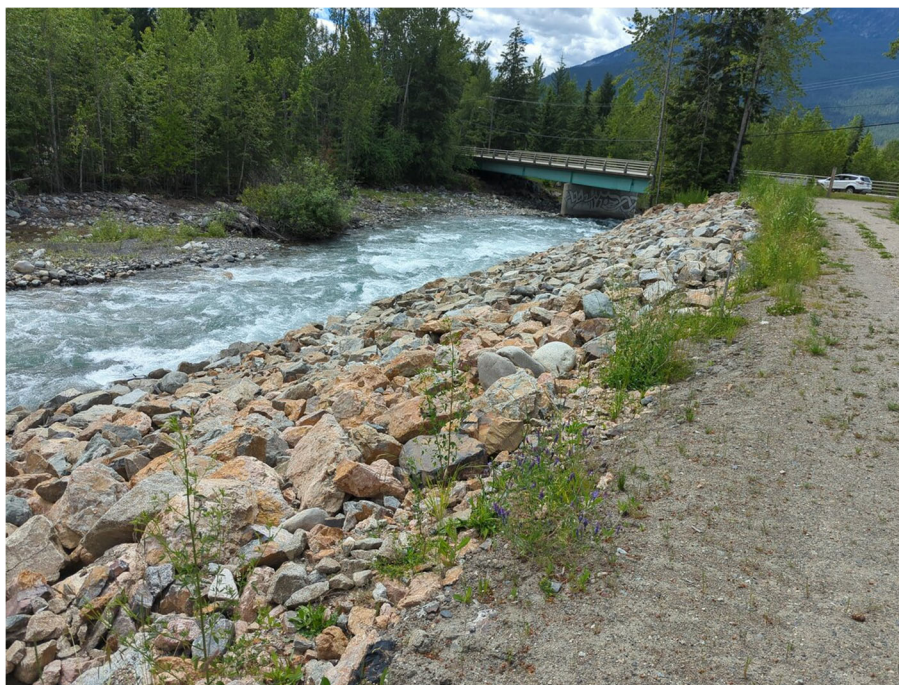
FIGURE 2-2: EXISTING RIPRAP PROTECTION UPSTREAM OF HIGHWAY 6

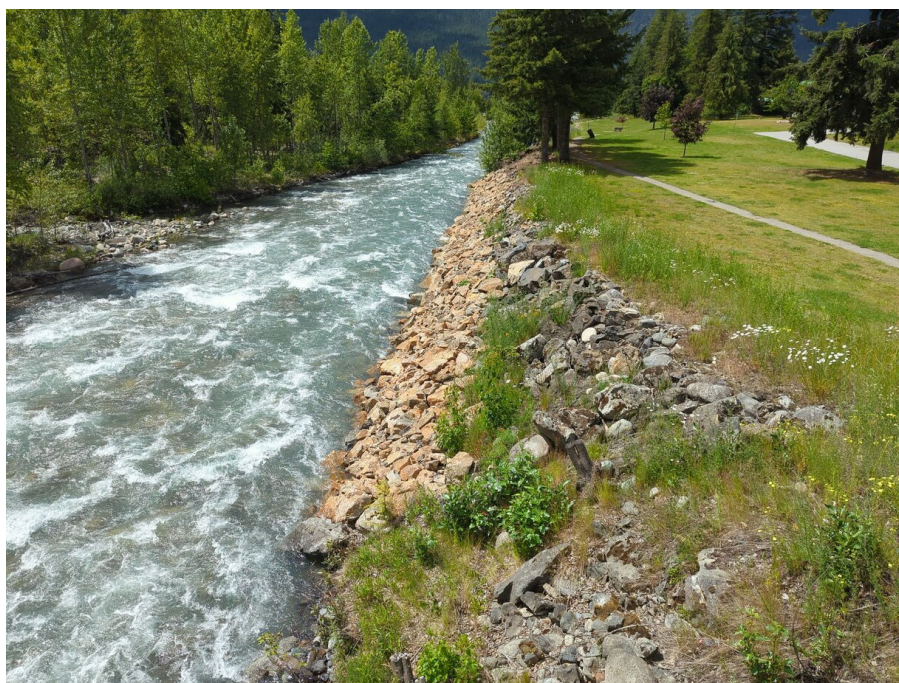
FIGURE 2-3: EXISTING RIPRAP PROTECTION DOWNSTREAM OF HIGHWAY 6

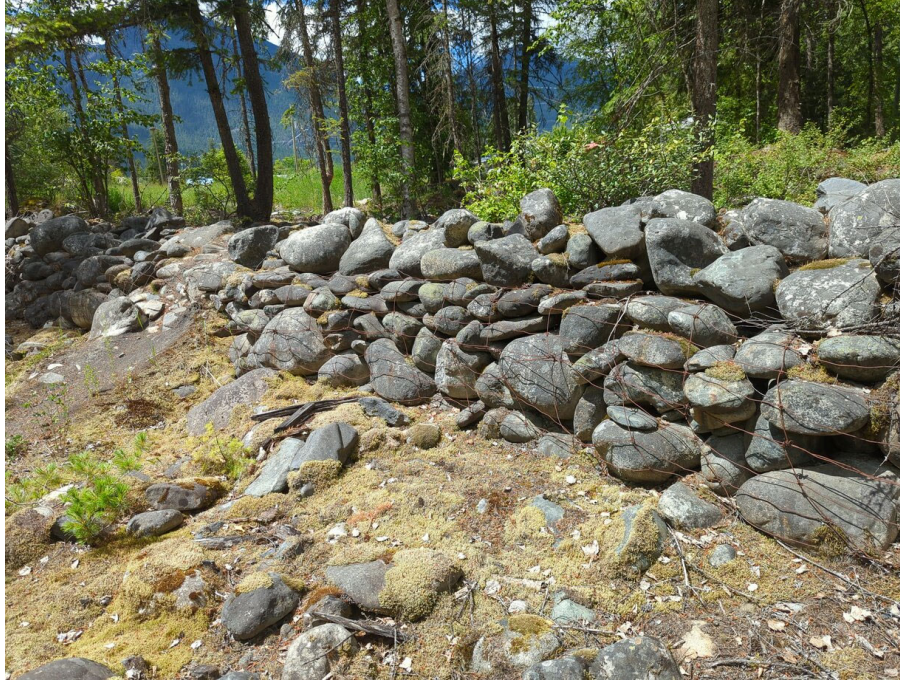
FIGURE 2-4: RELIC BANK PROTECTION CONSISTING OF ROCK WRAPPED IN WIRE

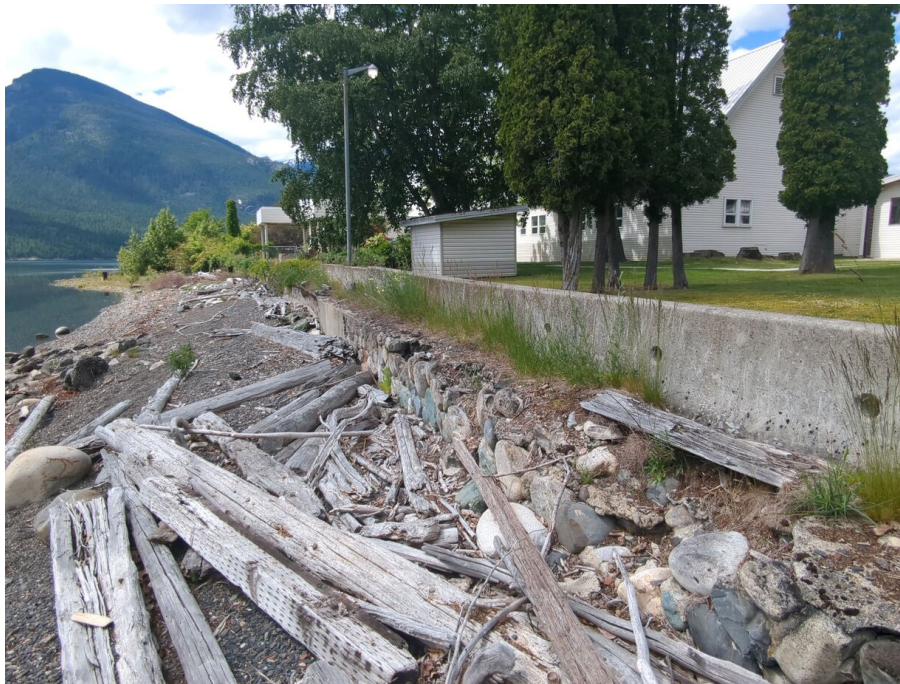
FIGURE 2-5: LOW LYING LAKESHORE TABLELAND ADJACENT TO THE HEALTH CENTRE

Low lying lakeshore shoreline adjacent to the Community Health Centre has a small concrete block wall installed on top of the lake bank to address wave related hazards from the lake. Figure 2-5 shows the photograph of the shoreline in this area.

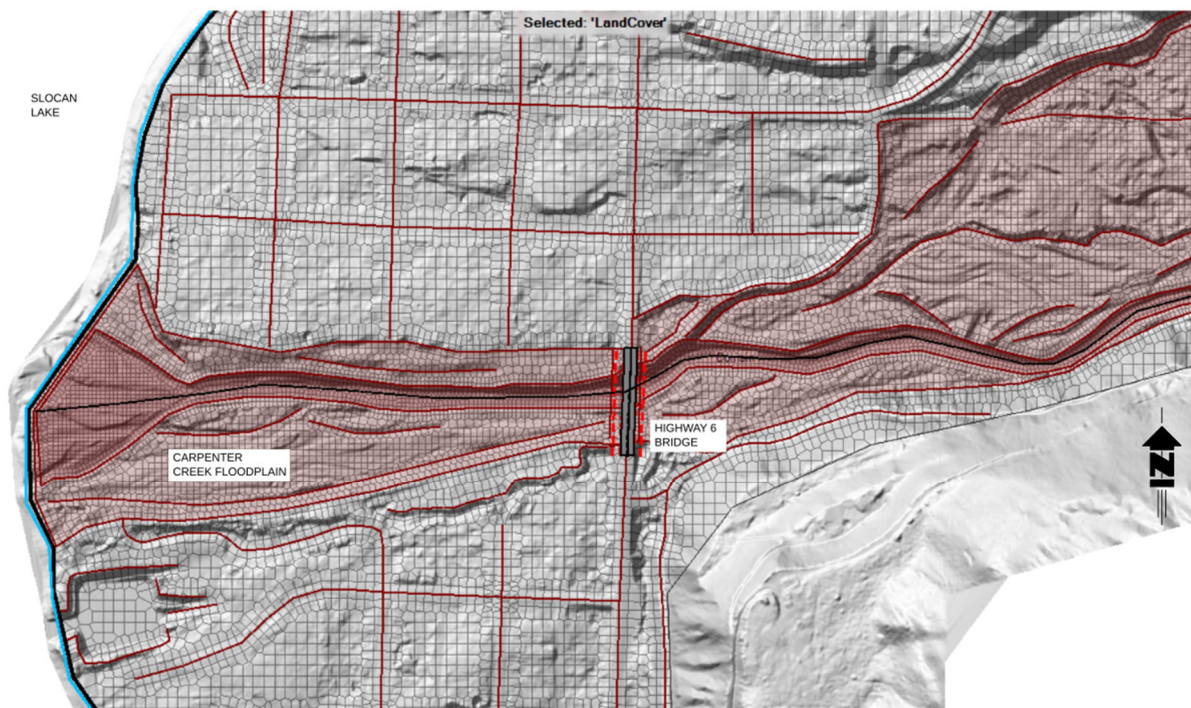
FIGURE 5-1: HEC-RAS 2D MODEL GRID AT NEW DENVER

A HEC-RAS 2D model schematic is presented in Figure 5-1, where the numerical model grid is shown, along with breaklines and hydraulic structures. Generally, areas within the 2D model domain that are anticipated to carry bulk of the flow are discretized with finer elements (such as main channels and hydraulic structures). Areas farther away were assigned larger grid cells, as these areas will likely not govern in controlling flow behavior (such as open fields for example). Model breaklines were placed at locations where geometry changes slope (like top of channel banks, tops, and bottoms of slopes, etc). When used properly, breaklines allow the model to limit the number of grid cells (and thus reduce computational time), while capturing relevant flow hydraulics.

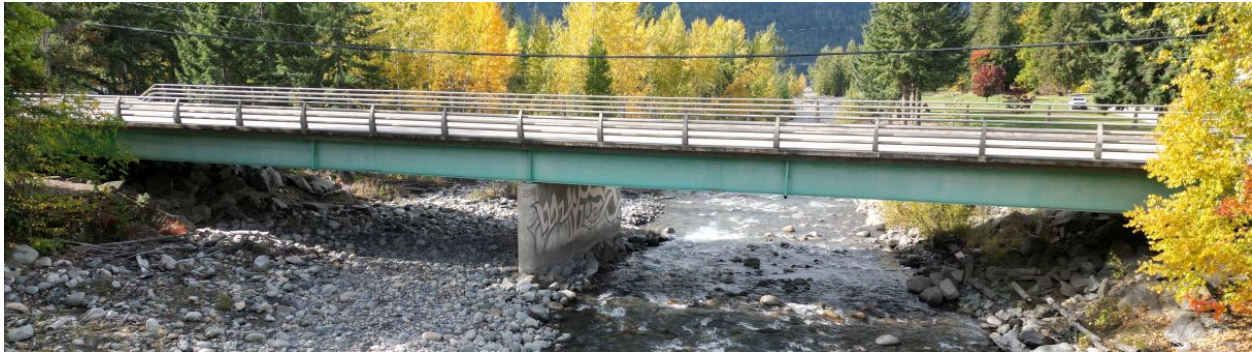
A photograph of the Highway 6 bridge is shown in Figure 5-2, while key technical measurements are presented in Table 5-2.

FIGURE 5-2: HIGHWAY 6 BRIDGE AT NEW DENVER, LOOKING DOWNSTREAM

width of pier, channel cross section, etc.) was used to represent the Highway 6 bridge in the model.

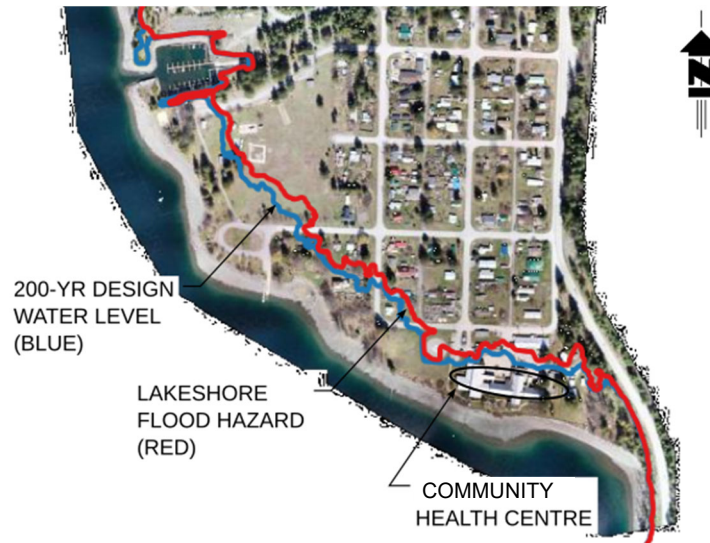
FIGURE 6-8: LAKESHORE HAZARDS AT COMMUNITY HEALTH CENTRE

Most notably, Figure 6-8 shows that most of the Community Health Centre property is within the footprint of the 200-yr design water level (200-yr water level plus 0.6m freeboard). The actual floor elevations of the Community Health Centre have not been confirmed. Given the gentle slope of the land, the lakeshore wave induced hazard marginally extends inland at this location, to account for the wave runup process (waves running up the shoreline during peak times of flooding).

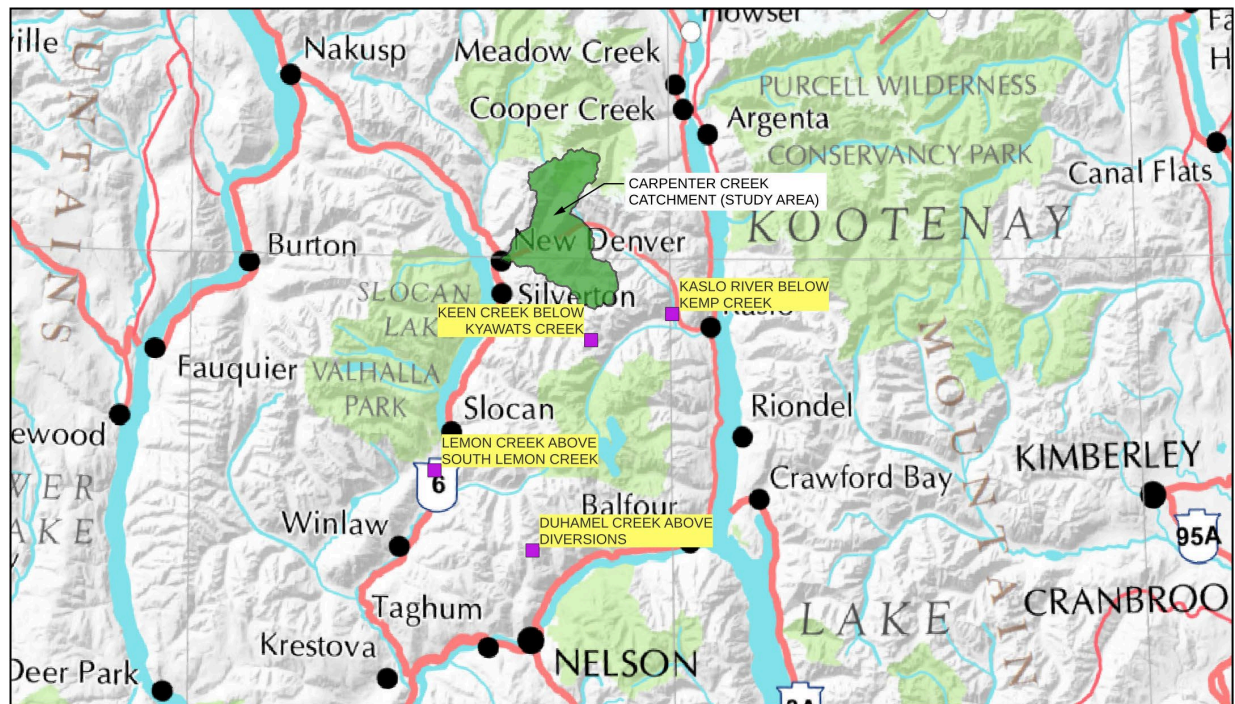
FIGURE 2-1: LOCATIONS OF STREAMFLOW GAUGES

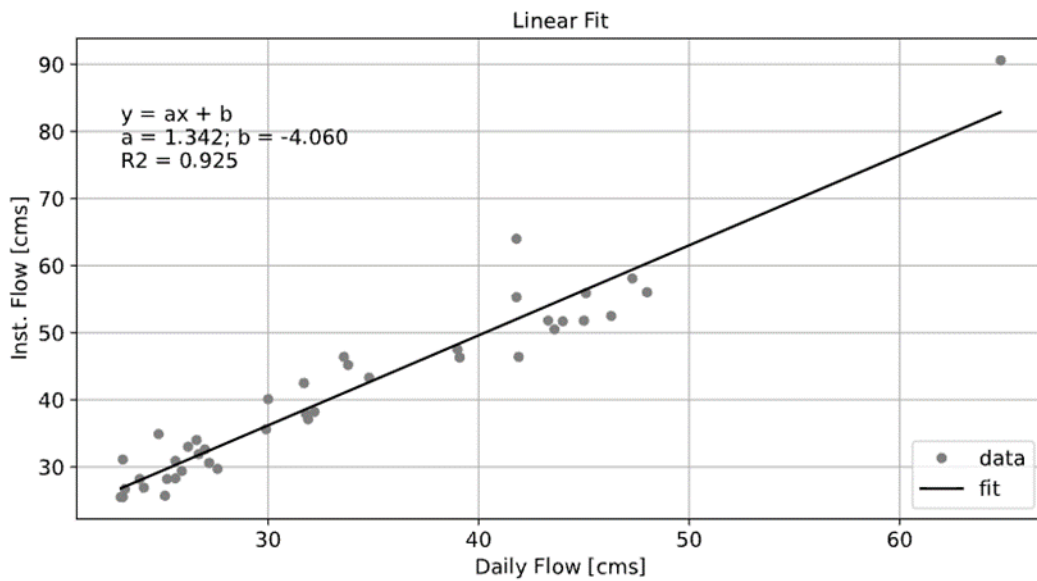
FIGURE 2-5: FRESHET DAILY TO INSTANTANEOUS RELATION FOR LEMON CREEK (08NJ160)

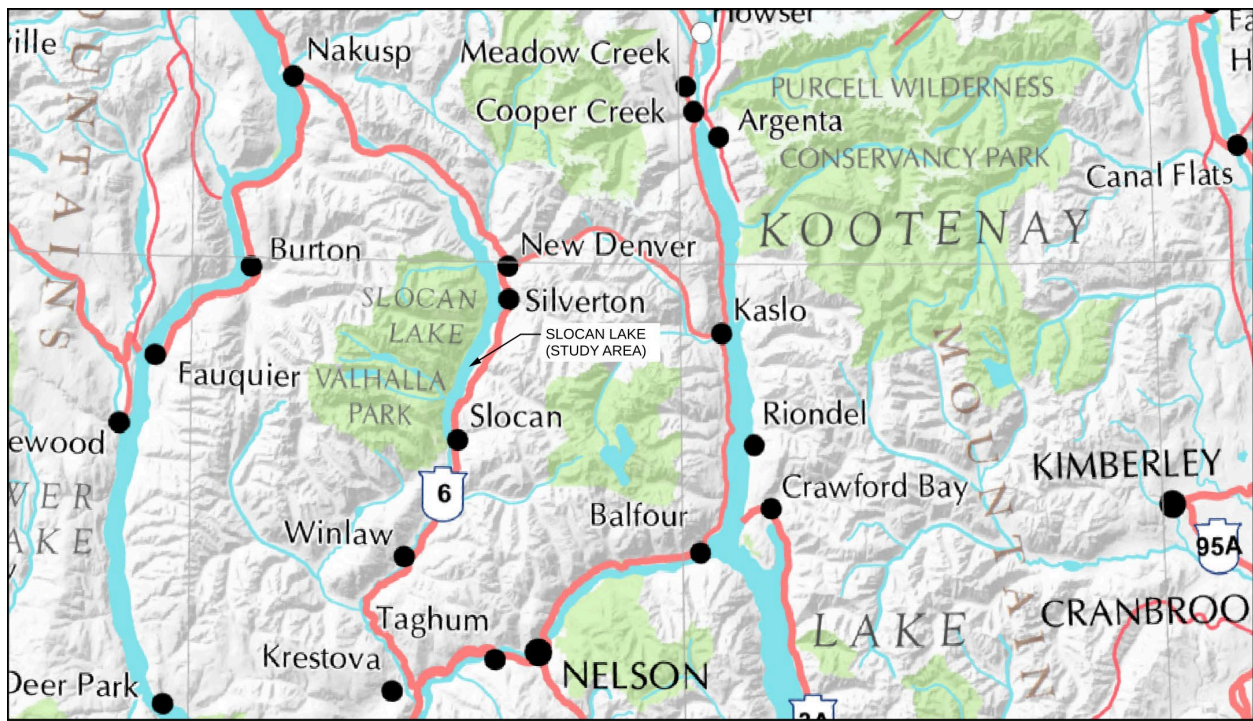
This report provides a summary of technical analyses undertaken to characterize water levels of Slocan Lake and regional wind speed for the purpose of completing lakeshore floodplain mapping for the Village of New Denver and Village of Silverton (See Figure 1-1). As both communities lie on the eastern shoreline of Slocan Lake and are relatively close together, the same analyses apply. The lakeshore flooding assessment is part of the overall floodplain mapping assignment for each community, where both lakeshore and riverine floods are being mapped.

FIGURE 1-1: PROJECT LOCATION

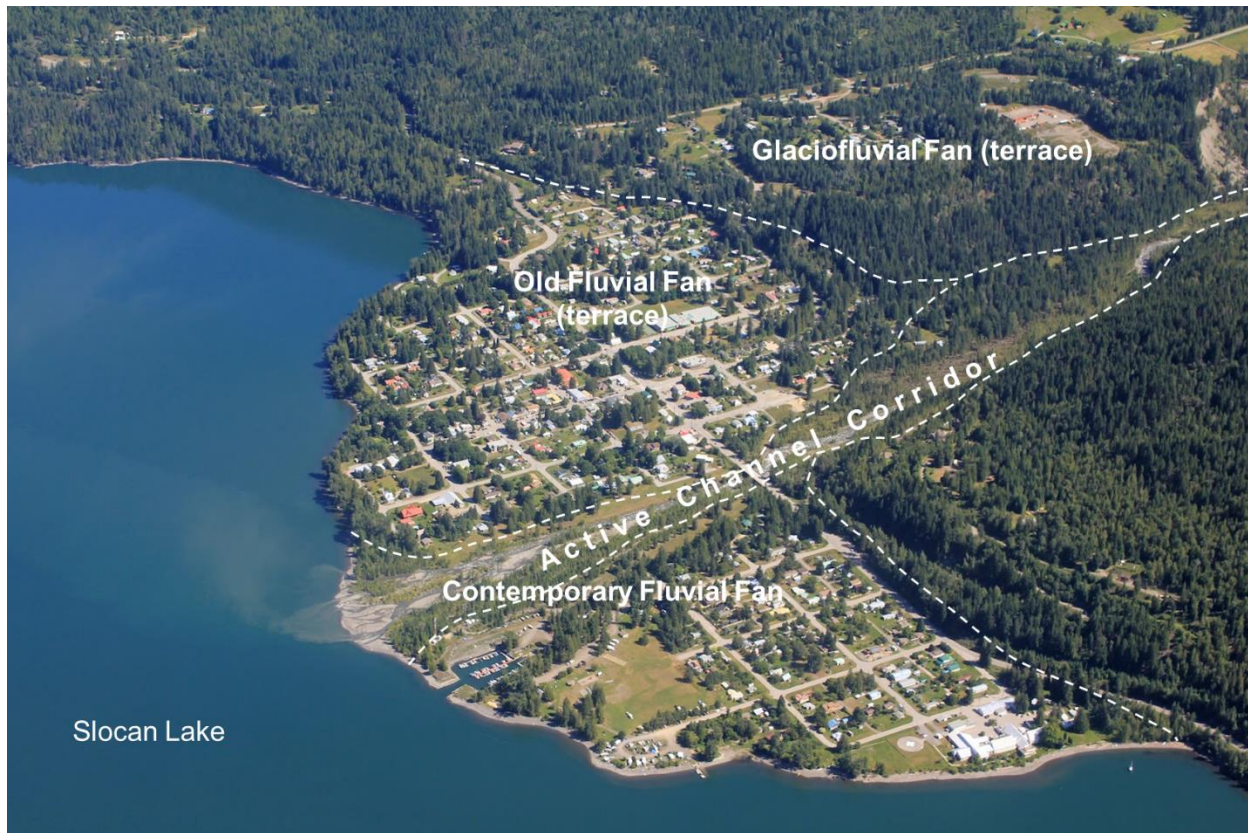
Photo 1: Oblique aerial view of New Denver and the fan complex on which it is situated at the mouth of Carpenter Creek (photo credit: J. Roberts).

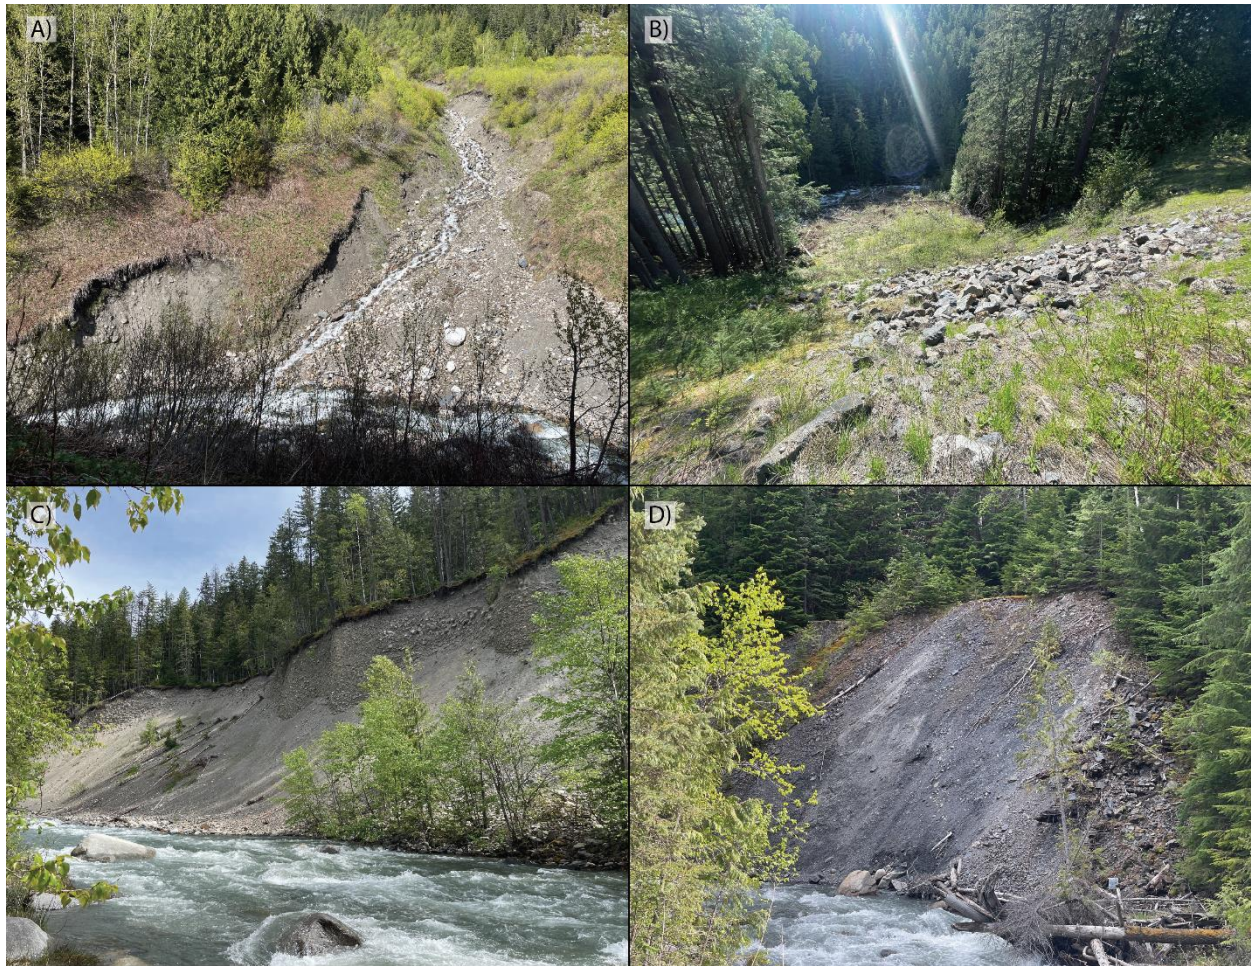
Figure 4: Examples of the dominant types of sediment sources to lower Carpenter Creek. A) Incised colluvial fan with eroded toe, about 1.5 km upstream of Sandon. B) Partially revegetated road embankment failure, about 3 km upstream of the Three Forks. C) Ravelling glaciofluvial terrace scarp about 0.7 km upstream of the Union Street bridge. D) Sloughing cut-bank into till about 0.4 km upstream of the Three Forks.

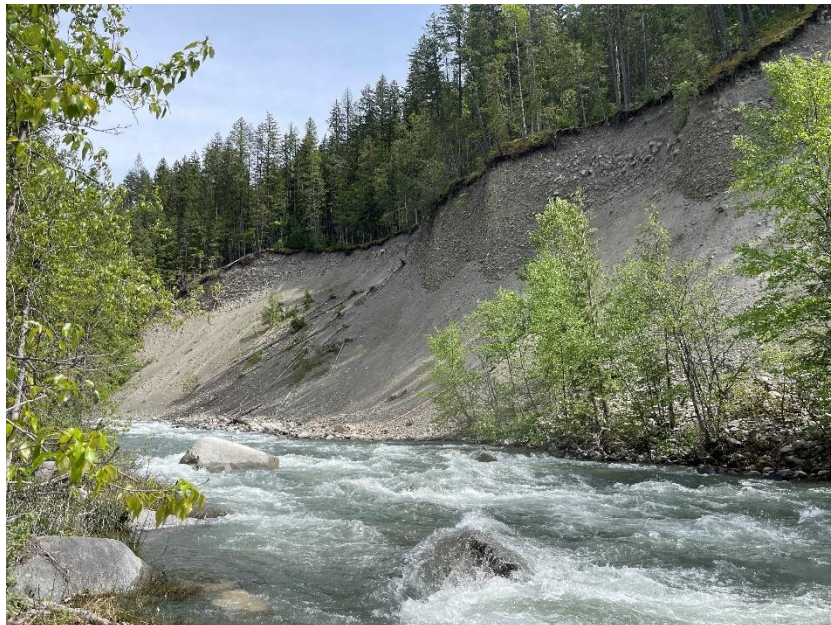
Photo 3: Upstream view of eroding scarp of remnant glaciofluvial (fan) terrace along the southern bank of lower Carpenter Creek, about 0.7 km upstream of the Bridge.

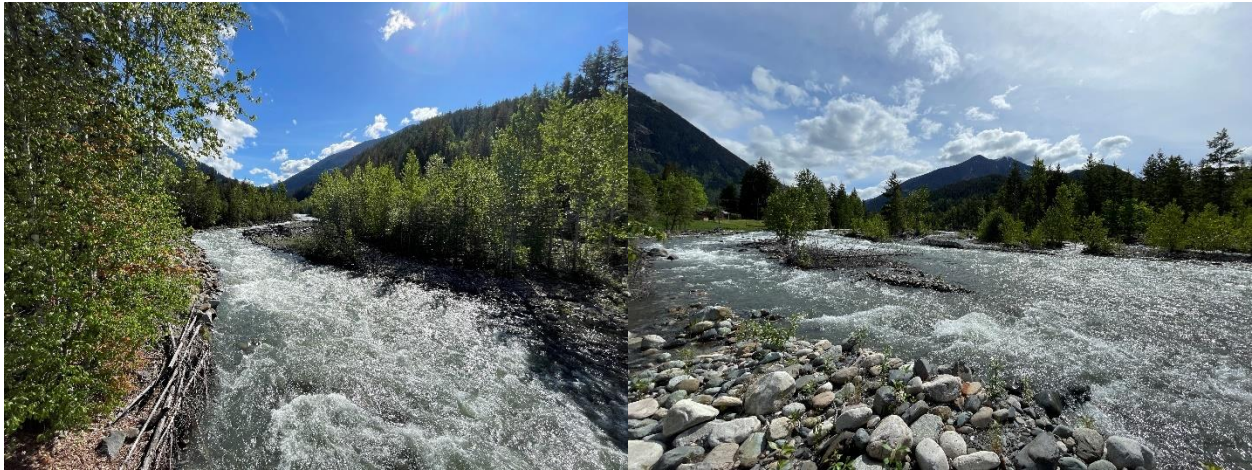
Photo 4: Upstream view from the Bridge at a sinuous, single-thread planform Carpenter Creek (left). Upstream view of a multi-thread planform of Carpenter Creek near its mouth (right).

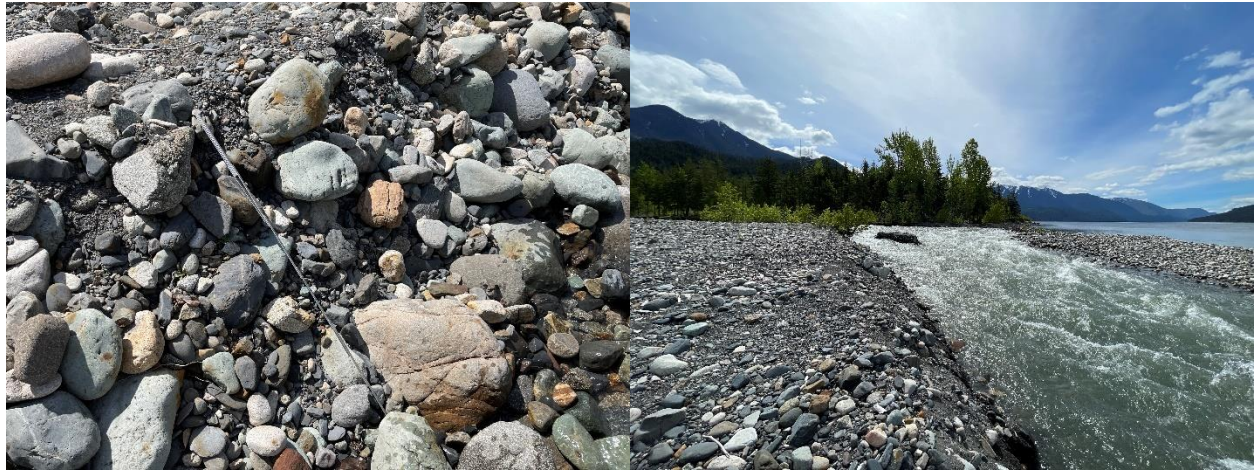
Photo 5: Overview of bed material (gravels and cobbles) at the edge of an active bar upstream of the Bridge (left; PC-2; note 60 cm steel folding rule for scale) and near the mouth of Carpenter Creek (right; PC-1). Note the slightly greater proportion of sand and pebbles nearer the mouth.

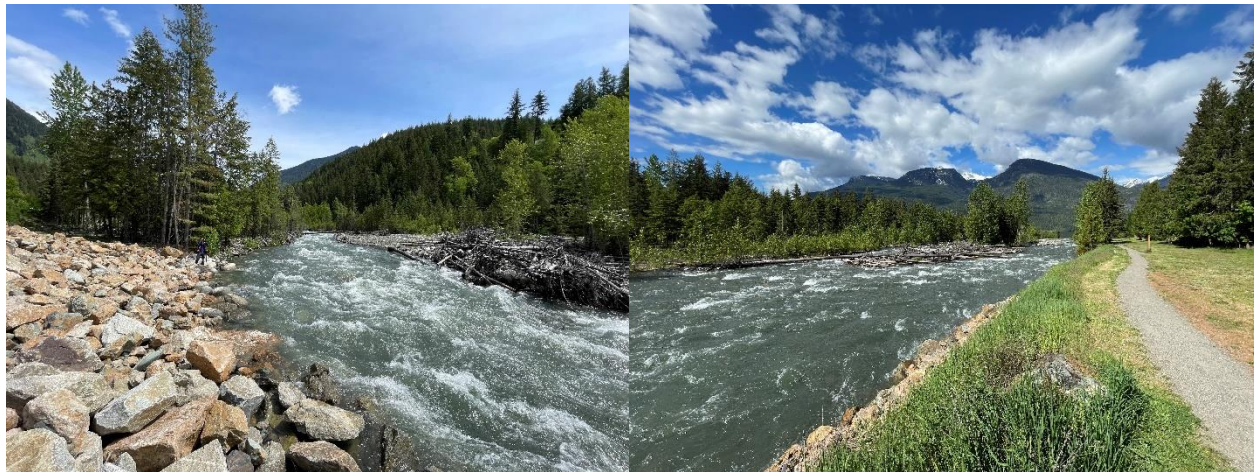
Photo 6: Upstream view of large wood jam opposite the recently repaired section of dike upstream of the Bridge (left) and downstream view of mid-channel jam downstream of the Bridge that is bifurcating flow (right).

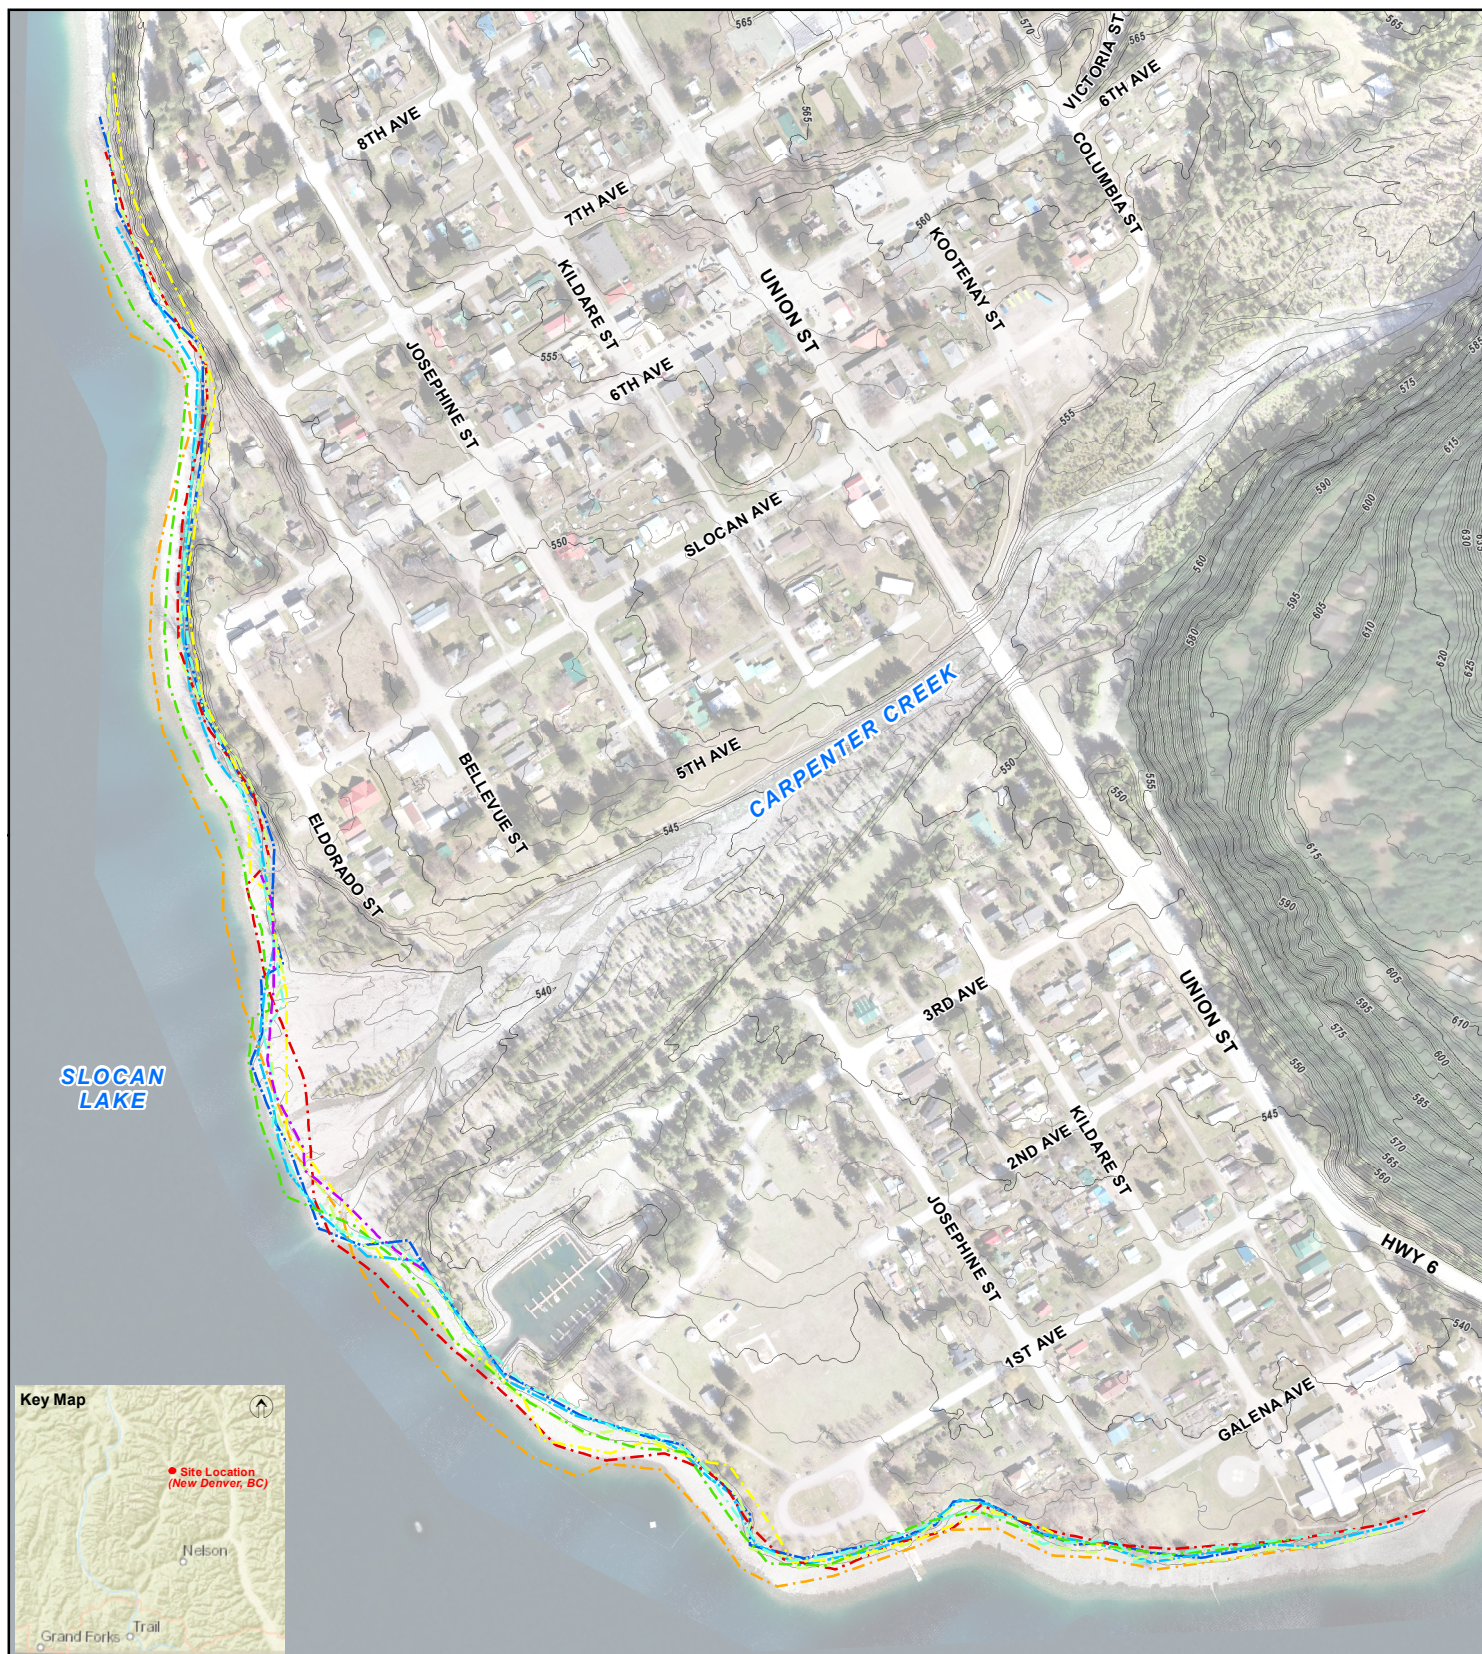
Figure 8

Comparative analysis of channel (**Figure 8**) and fan-front (**Figure 9**) positions since the earliest available aerial photography (1939), when combined with targeted field observations, revealed a variety of natural and anthropogenic changes in channel/fan morphology that warrant consideration as part of flood-related hazard assessment. Pertinent findings are described below for the Carpenter Creek channel (Section 4.3.2.1), flood/erosion mitigation dike that protects the north abutment of the Bridge (Section 4.3.2.2), and fan-front at the shoreline of Slocan Lake (Section 4.3.2.3).

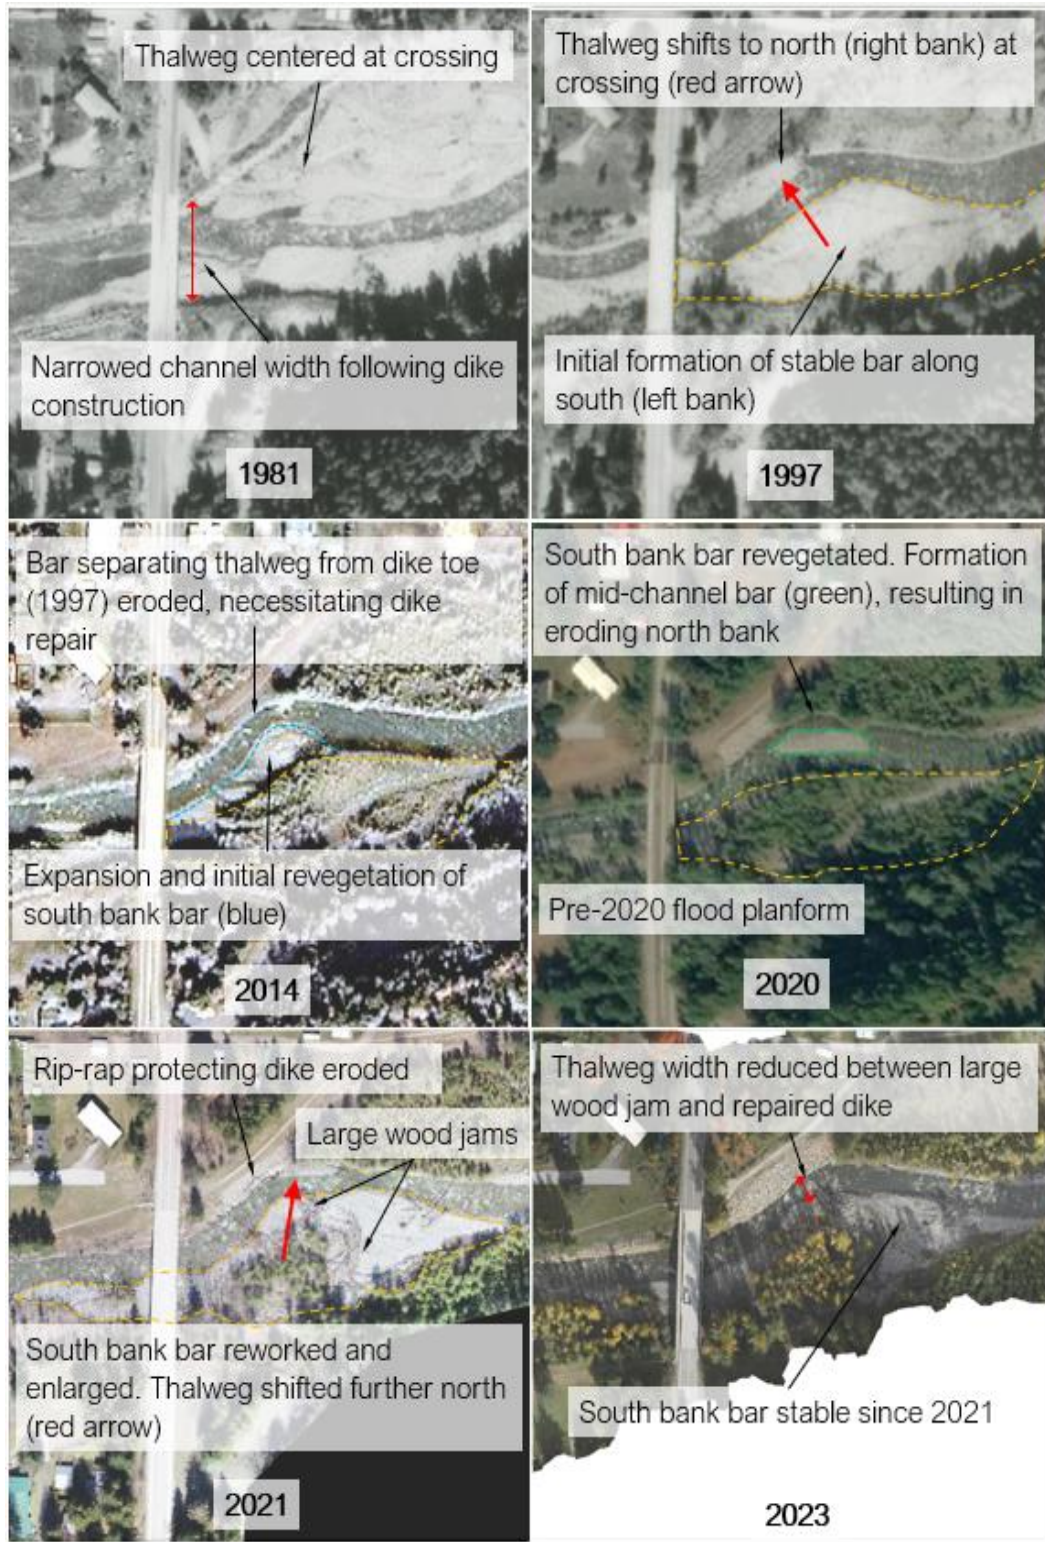
Figure 10: Comparison of historical imagery at the Bridge from 1981 (first available image following dike construction) to 2023. The channel thalweg has shifted northward to the dike, where it has remained in contact for approximately 40 years.

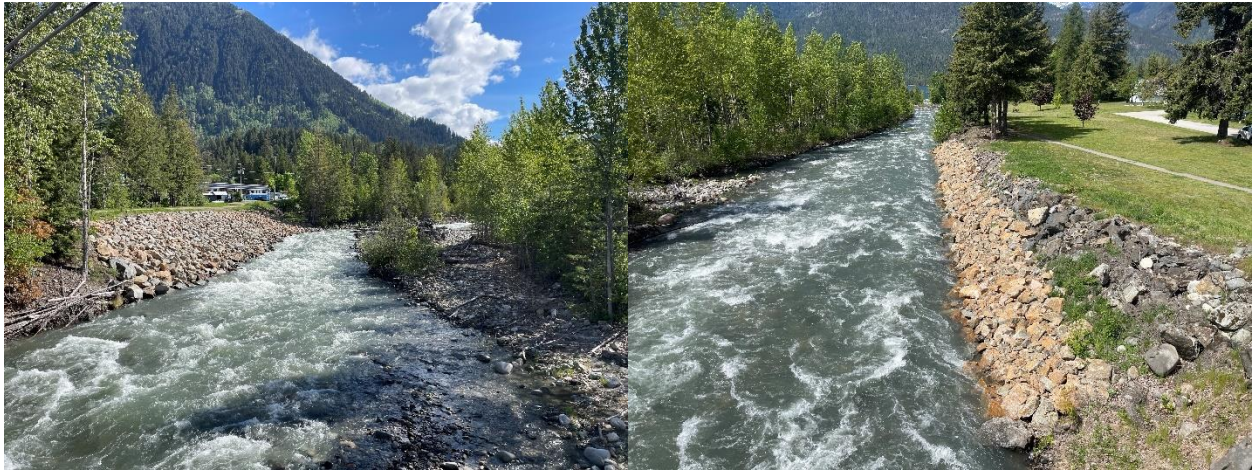
Photo 7: Recently placed rip-rap following scour during the 2020 flood (orangey tan colour). Rip-rap repaired upstream of the bridge (left, upstream view) has larger material (up to 1,200 mm), whereas the downstream portion (right, downstream view) has smaller material (up to 400 mm). The smaller material has a higher chance to be displaced based on the sediment mobility analysis.

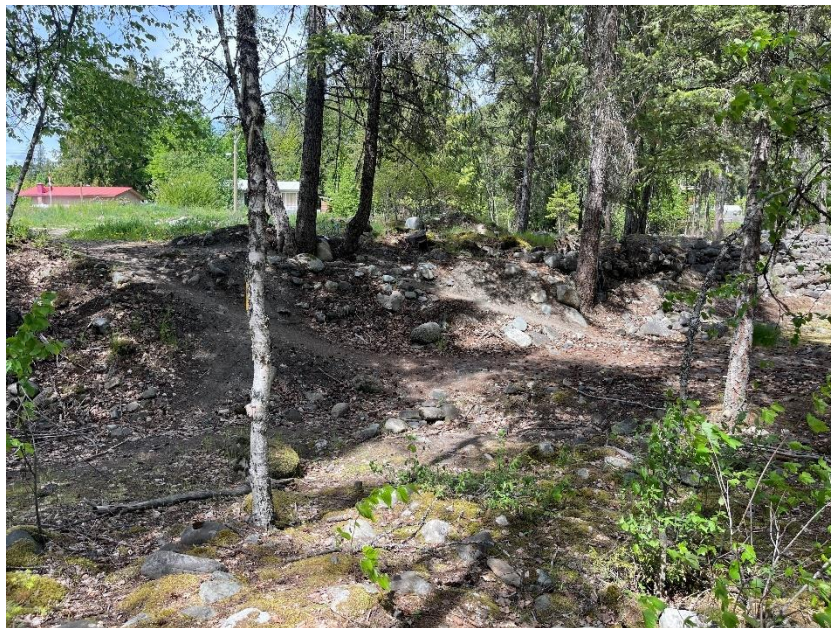
Photo 8: Northeast view along the upstream portion of the dike protecting the Bridge, looking toward the intersection of Slocan Avenue and Columbia Street. Note this section of dike, although locally set back from the active channel, is constructed of erodible, cobbly fan deposits.

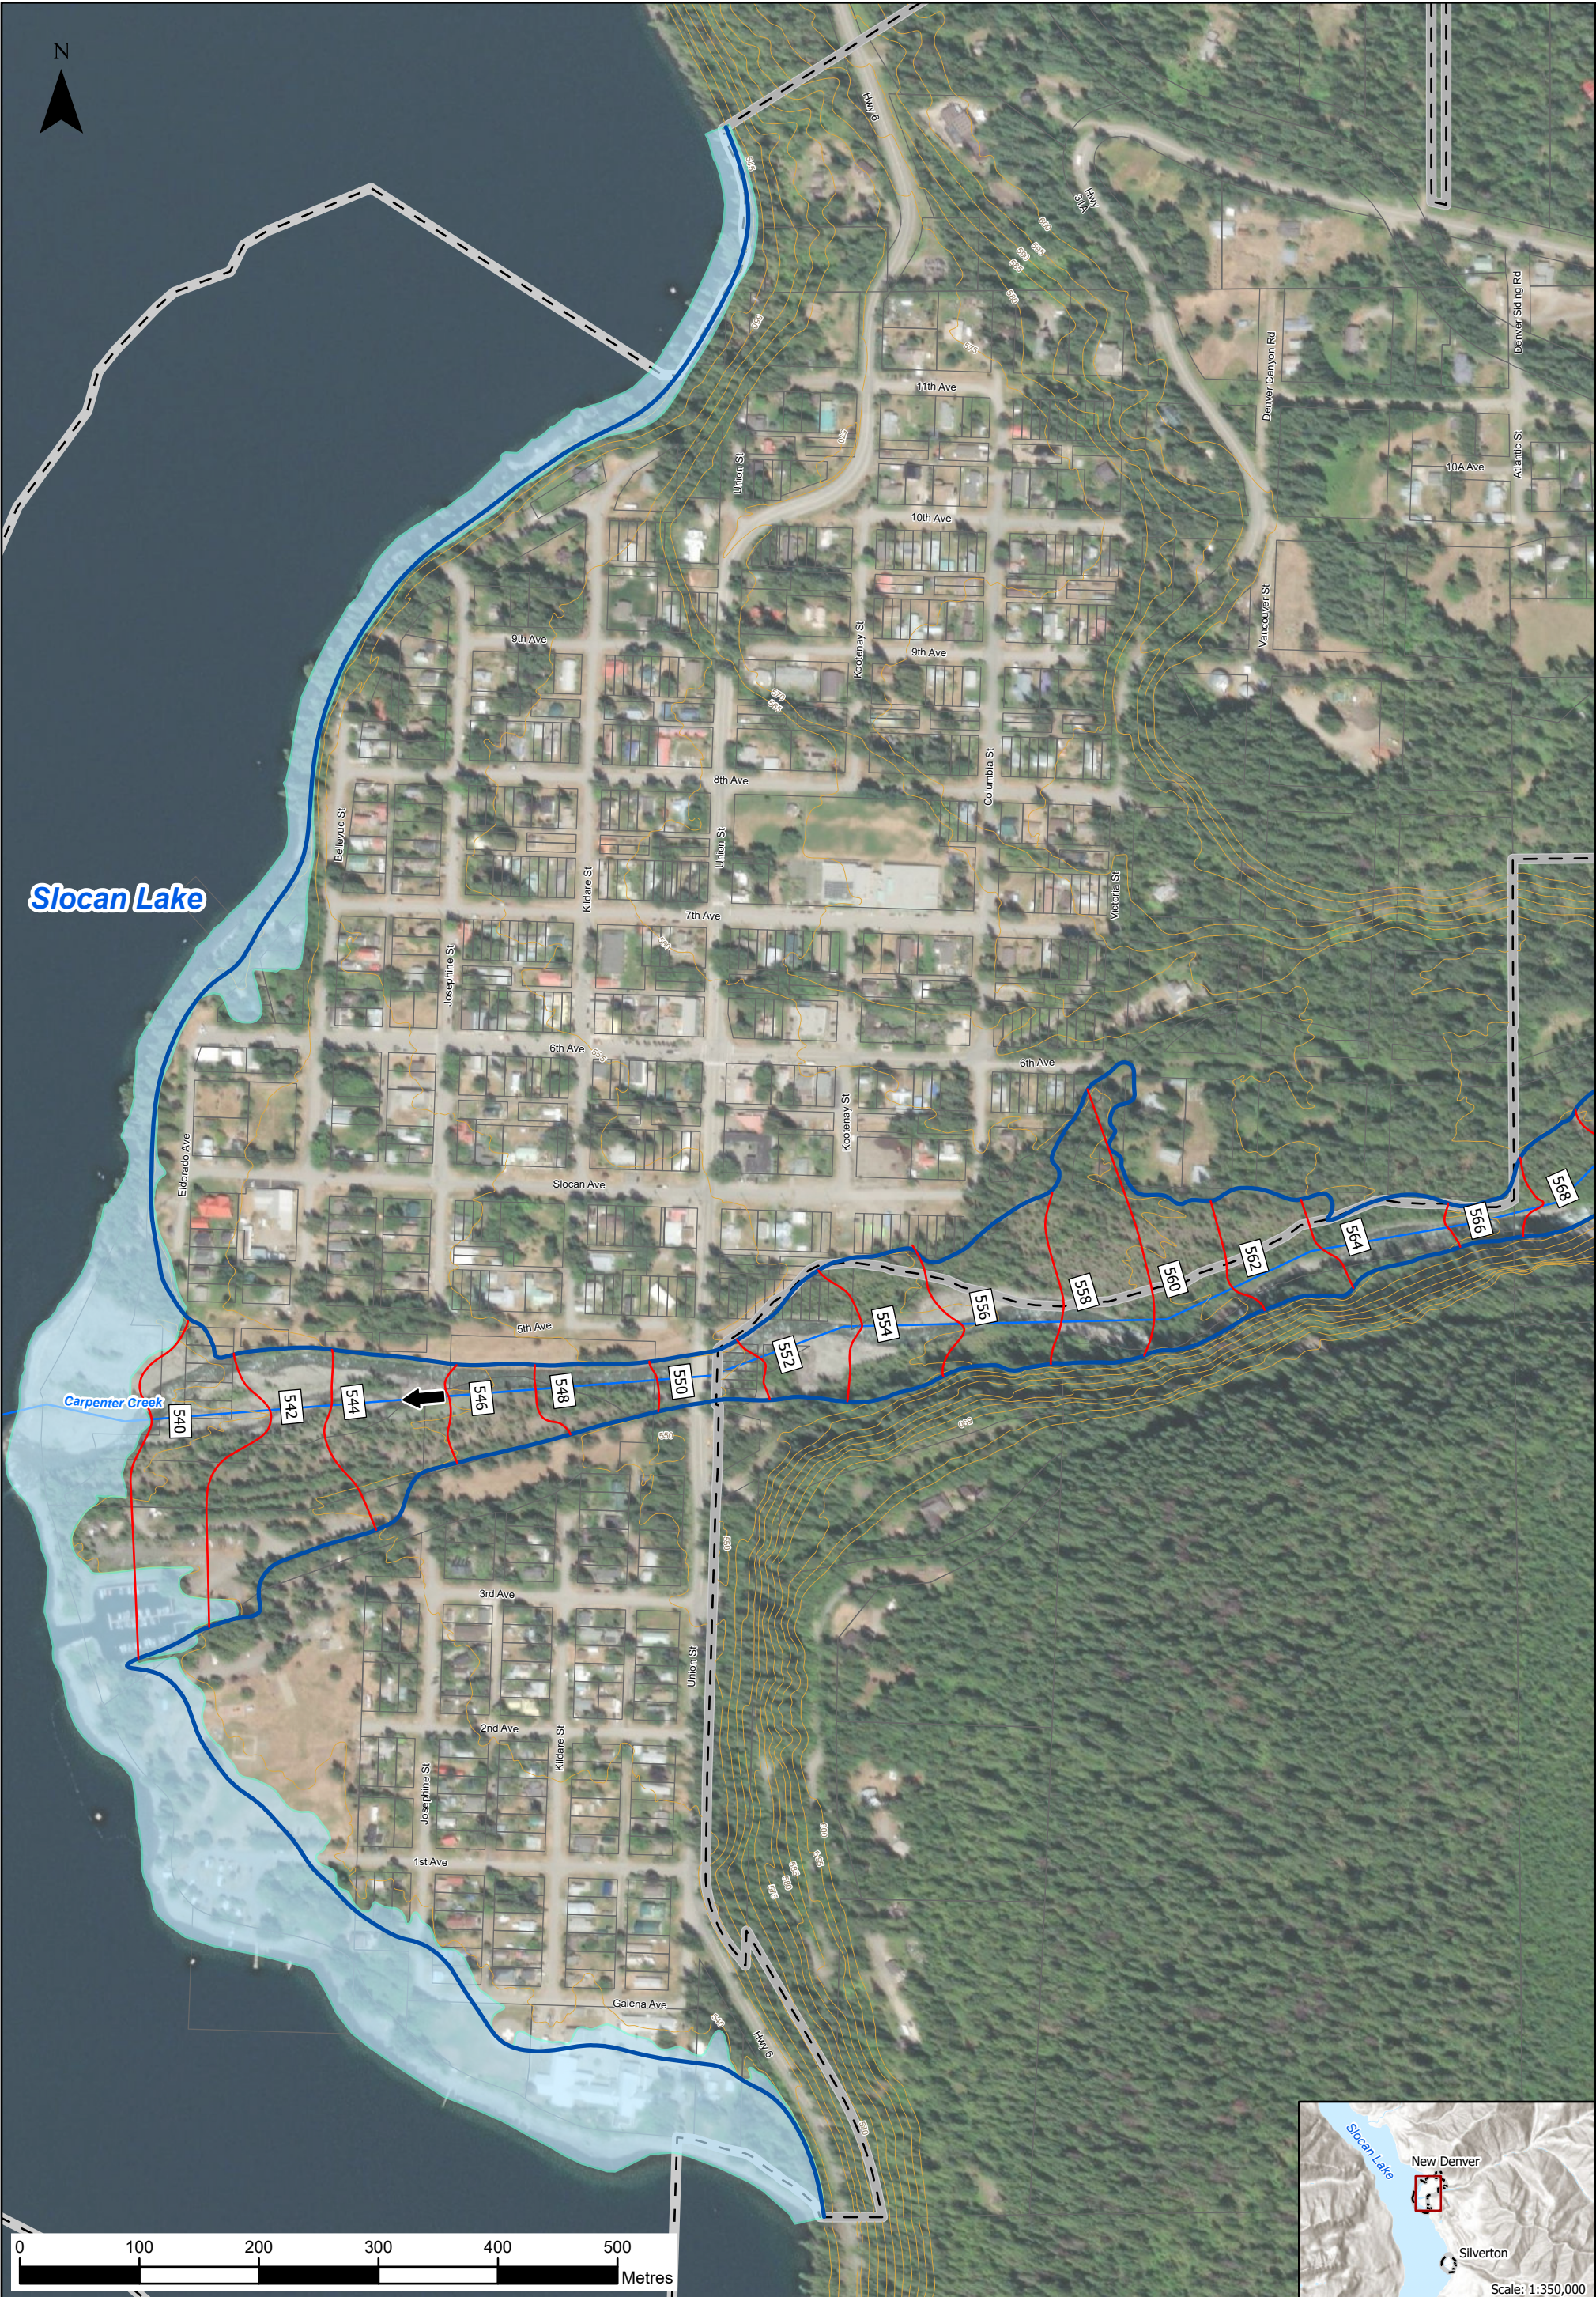
**200-Year End of Century
with Climate Change
Flood Hazard Map**

The results of flood modelling and associated mapping of hazard limits by TRUE (2025) indicate regular floods up to the 200-year return flow, plus a 0.1 times bulking factor and climate change factor, are contained within the active channel corridor between the rip-rapped flood/erosion control dikes. These results are based on current channel bed elevations and cross-sectional geometry. A more conservative assessment of flood hazard limits would consider the possibility of sudden accumulation of bed material and/or woody debris impeding flow along the active channel corridor, to a point that floodwater spills overbank and inundates adjacent areas of the contemporary fan of Carpenter Creek. If such an accumulation formed downstream of the Bridge, the portions of fan closest to the active channel corridor would most likely be affected soonest and to the greatest depth (**Figure 11**). This inundation zone would terminate at the marina and generally be within the limits of the flood-prone width of Carpenter Creek as recently as 1966 (**Figure 8**). Prior to dike construction, the marina was damaged following a spring flood in 1974 (WSA Engineering Ltd., 2012). A more extreme accumulation could lead to backwatered floodwater spilling overbank around the intersection of Josephine Street and 3rd Avenue and flowing southwestward to the fan front at Slocan Lake.
