Village of New Denver Bosun Hall Building Assessment

9dot Engineering Inc.

Project Number: 16-013

Prepared for: Village of New Denver

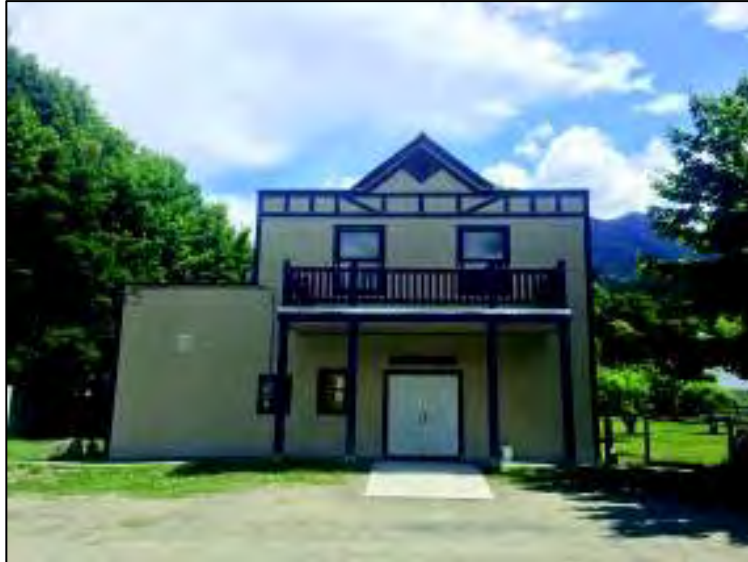
Figure 1 - Bosun Hall from Bellevue St.

In 2010 a new front façade was put on the building (Figure 1). This work also prompted a building inspection by Lynch Building Inspection Services on the stability of the roof, which recommended the replacement of the roof of the building immediately.

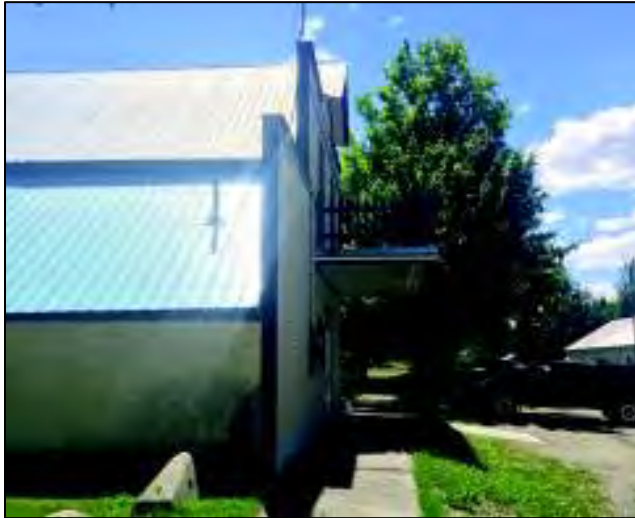
Bosun hall has one balcony structure that extends out over the main entrance facing West (Figure 15), and a small deck at the east facing kitchen door (Figure 16).

Figure 15 - Front Balcony
