**MITIGATING THE IMPACT OF STORMWATER RUNOFF
ON NEW DENVER'S DOMESTIC WATER SUPPLY
WELLS**

Prepared for the Village of New Denver

JUNE 2004

**RE: MITIGATING THE IMPACTS OF STORMWATER RUNOFF ON NEW DENVER'S
DOMESTIC WATER SUPPLY WELLS**

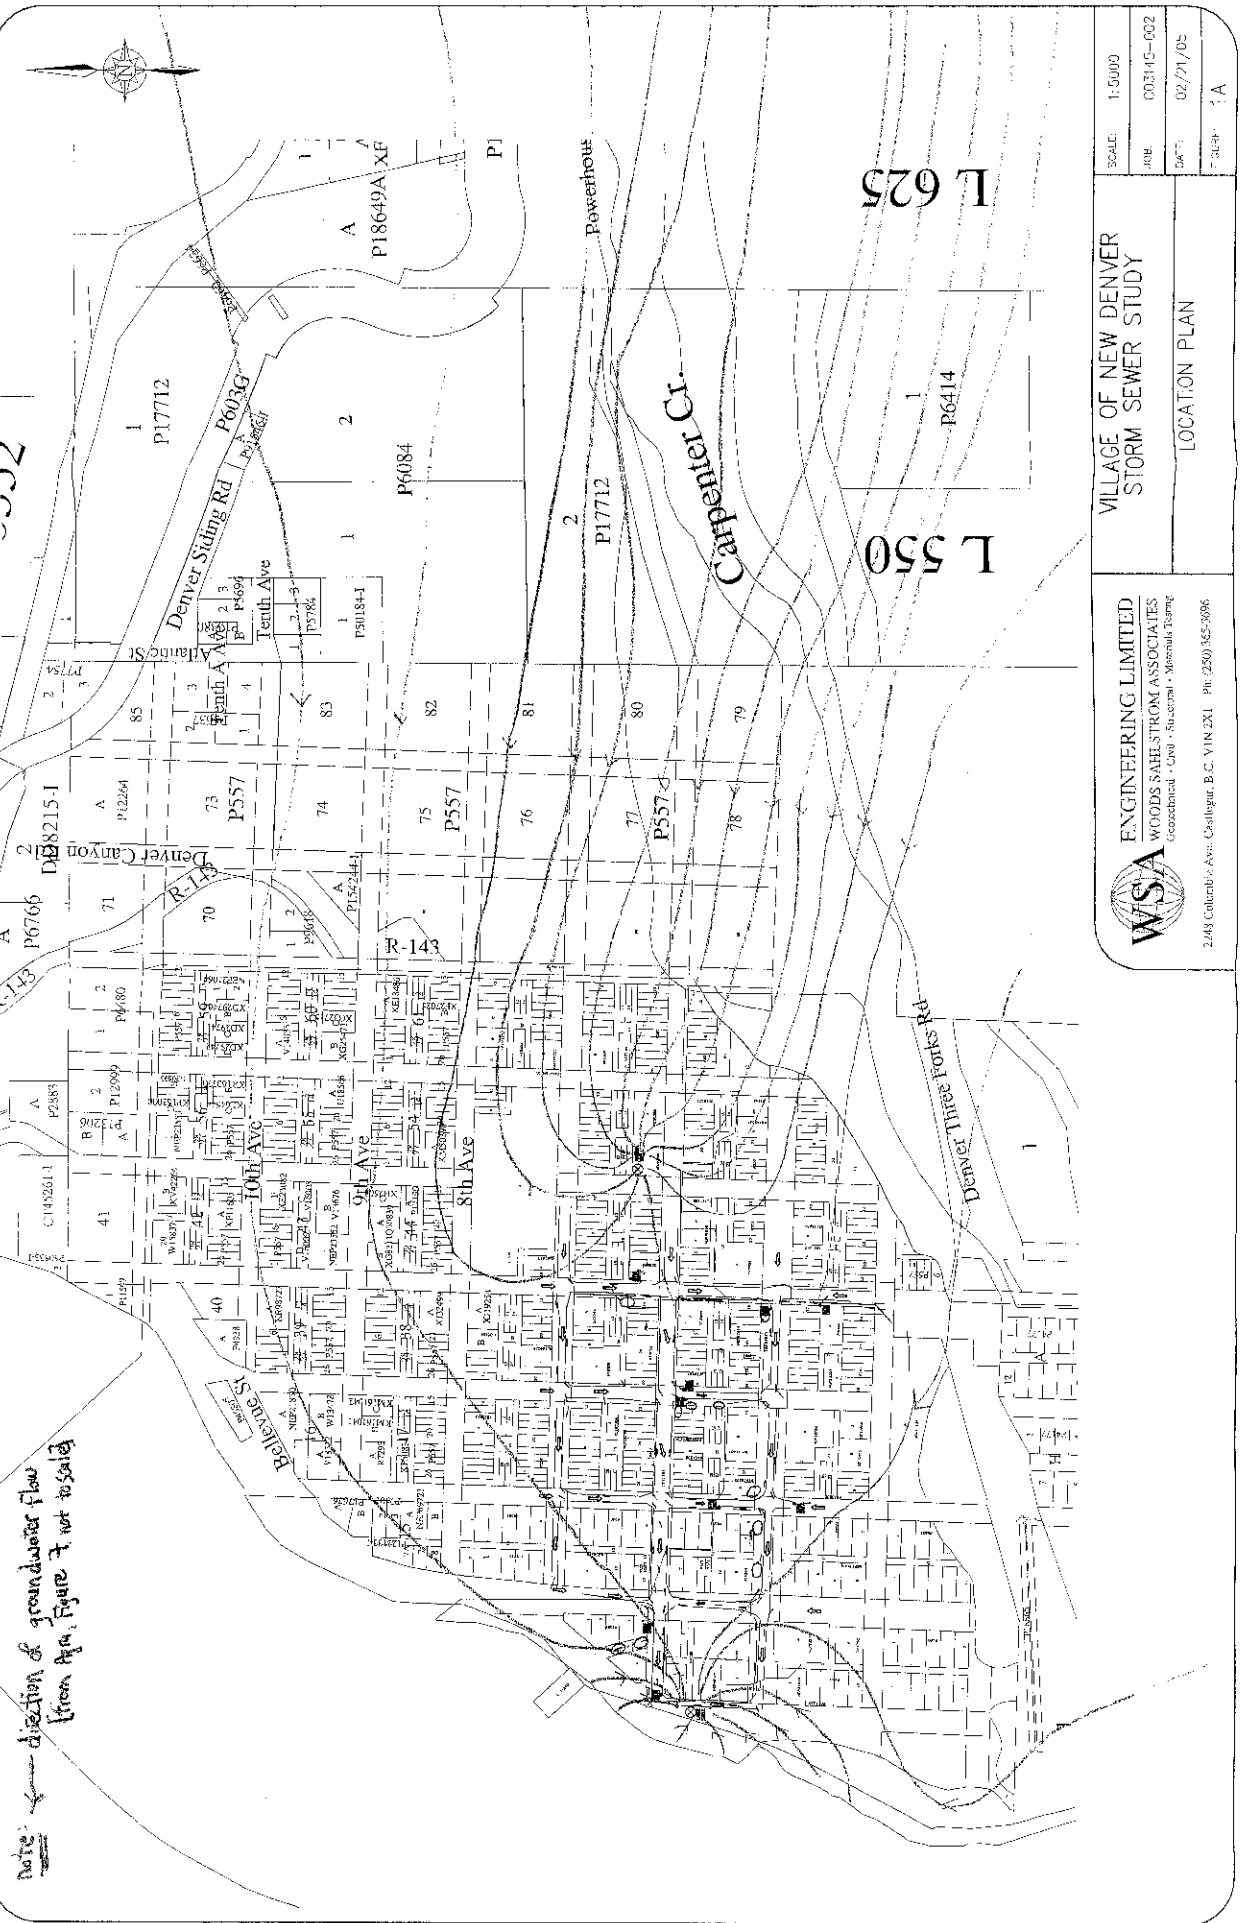
An inventory and inspection of the existing drywells was completed in June 2004. Drywell numbers can be referred to in the site plan of *Figure 1*. Drywells are generally constructed using one or two sections of precast perforated concrete with a solid section on top. The solid section has an open grated cover. Each section is about four feet in diameter and about three feet deep. Each perforated section contains five rows of perforations. The inspection revealed varying amounts of sand and silt deposited in the drywells, which block the perforations and reduce the effectiveness of runoff infiltration. A summary of the drywell inventory is given in *Table 1* on the following page.
